**DIGGING INTO A DUGOUT HOUSE (SITE 21SW17):
THE ARCHAEOLOGY OF NORWEGIAN IMMIGRANT
ANNA BYBERG CHRISTOPHERSON GOULSON,
SWENODA TOWNSHIP, SWIFT COUNTY, MINNESOTA**

Technical Report No. 480

May 2003

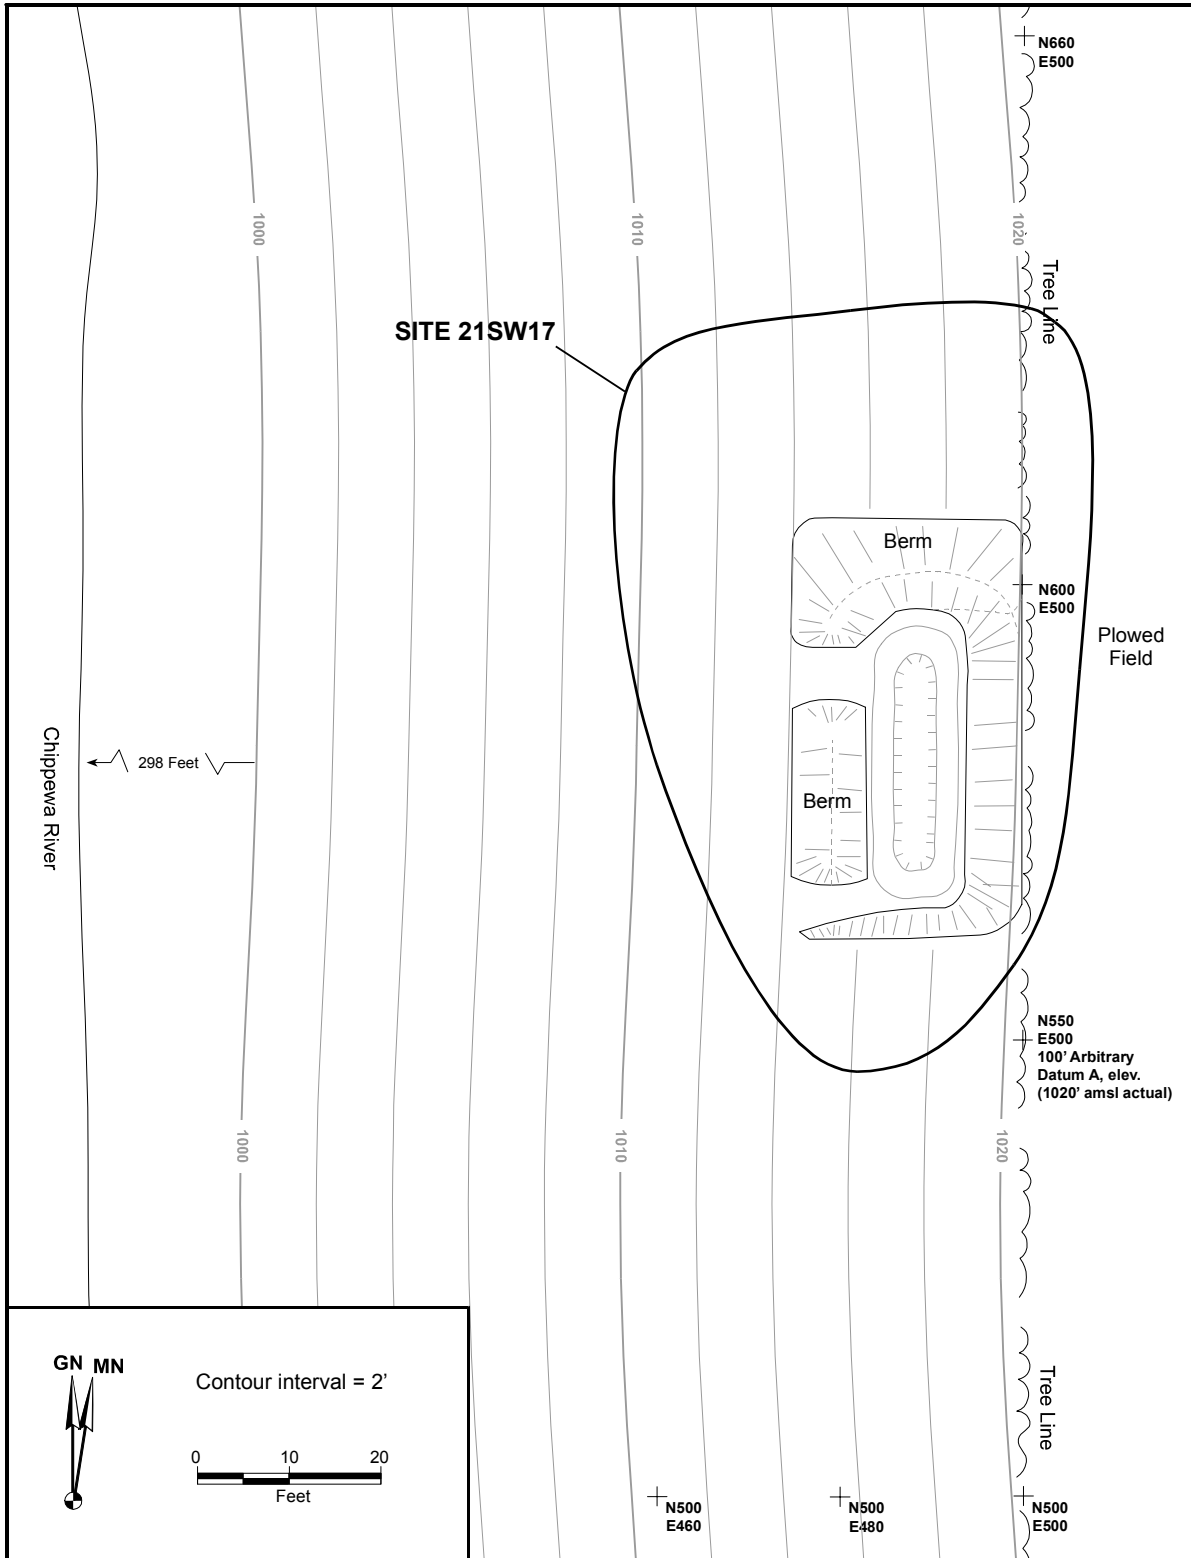
Figure 1.3. Plan of the Christopherson/Goulson digout site area.

The site consists of a large depression and earthen berms located at the break of the bluff slope; a cultivated field borders the wooded site on the east (Figures 1.3 and 1.4). The area was covered in trees, most of which are 30-50 years old, and a very thick understory vegetation of

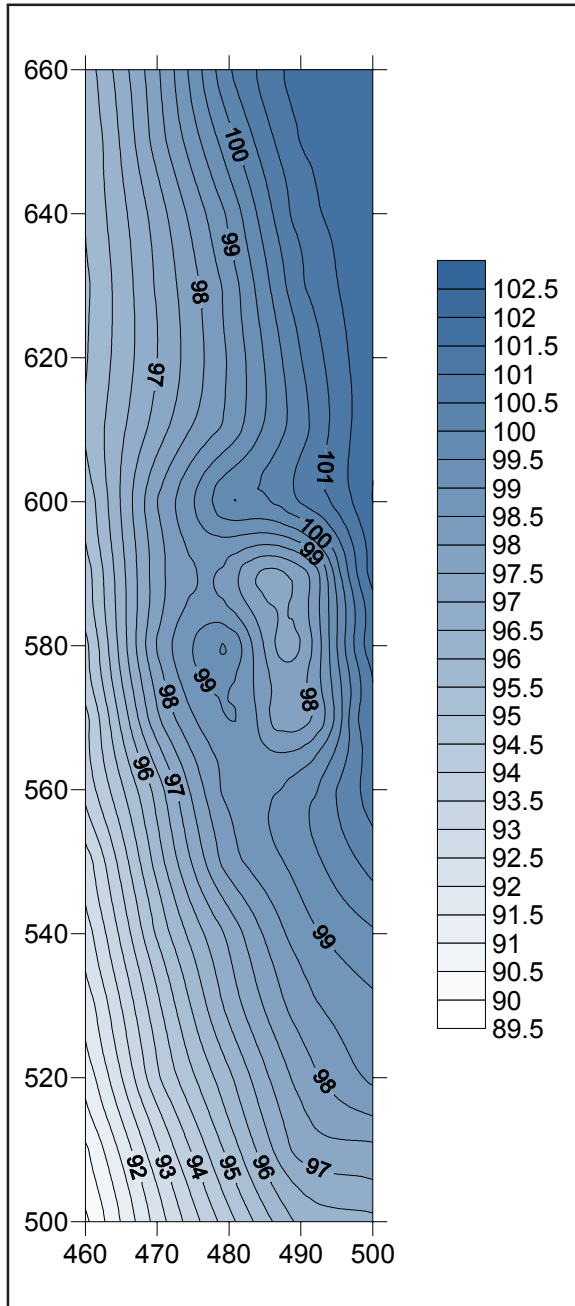
Figure 1.6. Detailed topographic map of dugout depression.

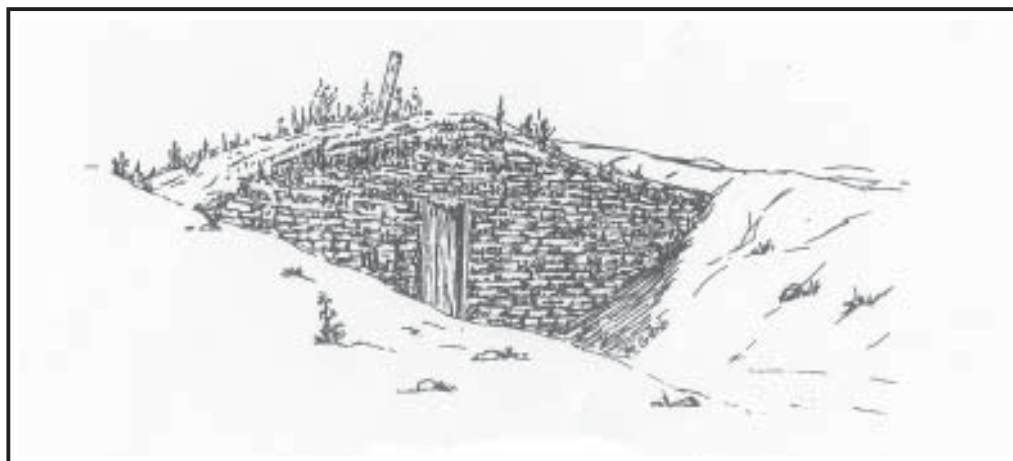
Figure 2.10. Sketch of a dugout house (from Noble 1981:15).

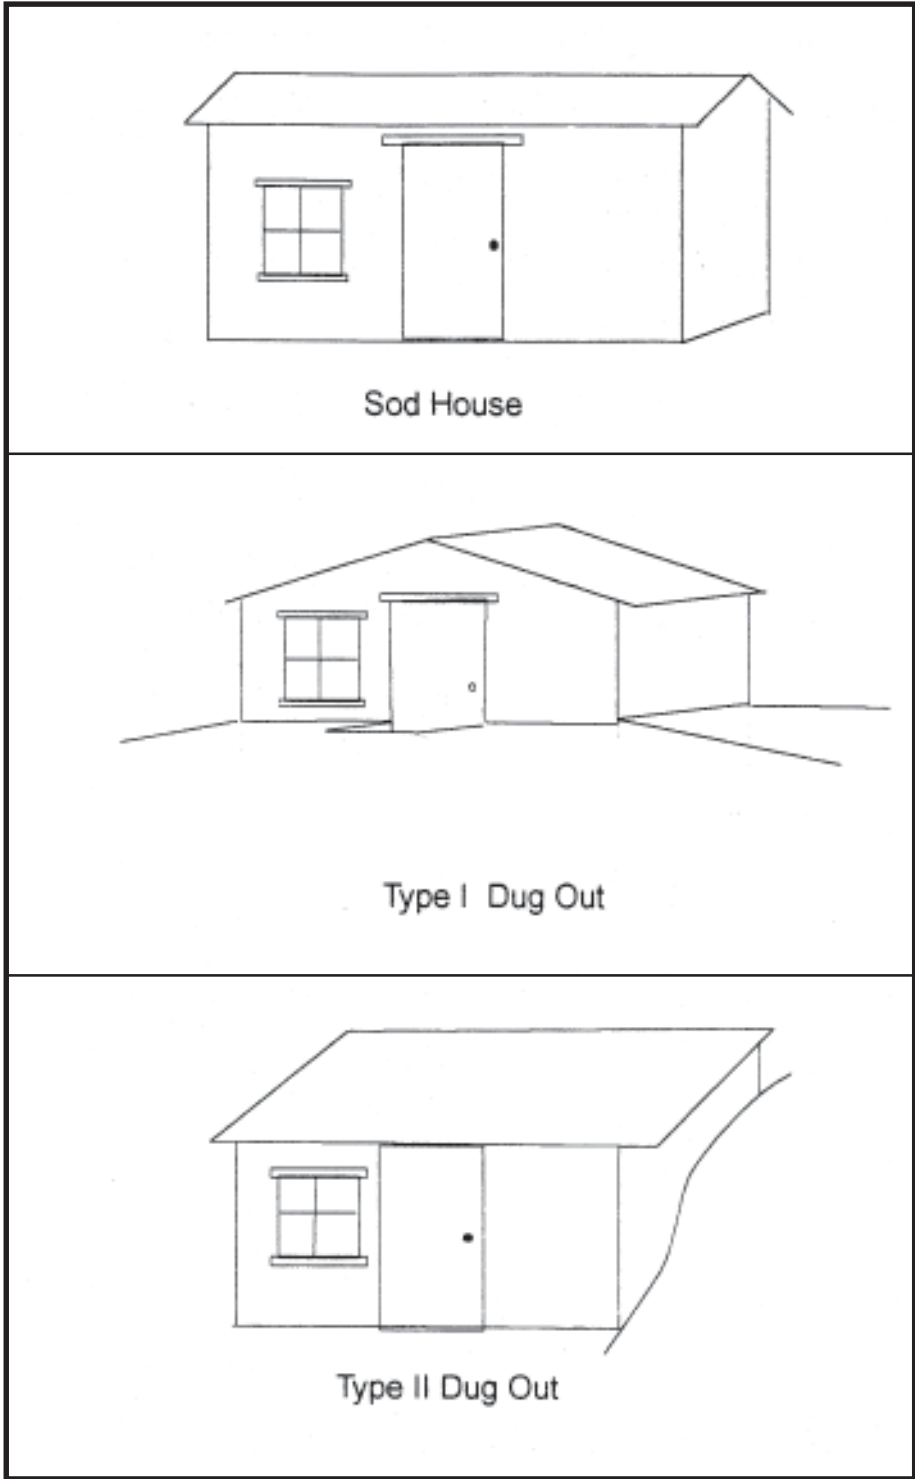
Figure 2.11. Types of sod and dugout houses (after Broste 1995:175).

In his thesis on the Ole Palme dugout, Broste (1995:172) distinguishes the sod house, “made by laying courses of sod block on a level ground surface,” from two types of dugouts. The Type I Dug Out was built on level ground but was semi-subterranean (Figure 2.11). “Their floors were dug into the ground rather than left at ground surface. The upper portion of the walls were of sod or logs, while the lower were of the soil profile.” Broste’s Type II Dug Outs were built into a slope, as noted by Caspers. The walls of these structures “were dug into the hillside....[and] utilized the soil profile and sod block or logs” (Broste 1995:173).

the structures were excavated into a hillside overlooking a river valley setting (Type II), or on flatter land near the edge of the river valley (Type I) (see Figure 2.11). The archaeological evidence that survives suggests that these structures had log or earthen, sod block walls and were covered by gable or shed roofs constructed of either dimensional lumber or small pole rafters with a covering of woven saplings and grass. These one room structures were generally heated with wood stoves, and may have had a glazed window or two. A doorway, often on the south wall, was accessed via an earthen stair or entrance ramp. The material culture assemblage recovered from the various dugouts that have been investigated is generally quite sparse compared to typical dwelling sites of the period. In some cases, the dugout cellars have been filled with trash from later occupations of

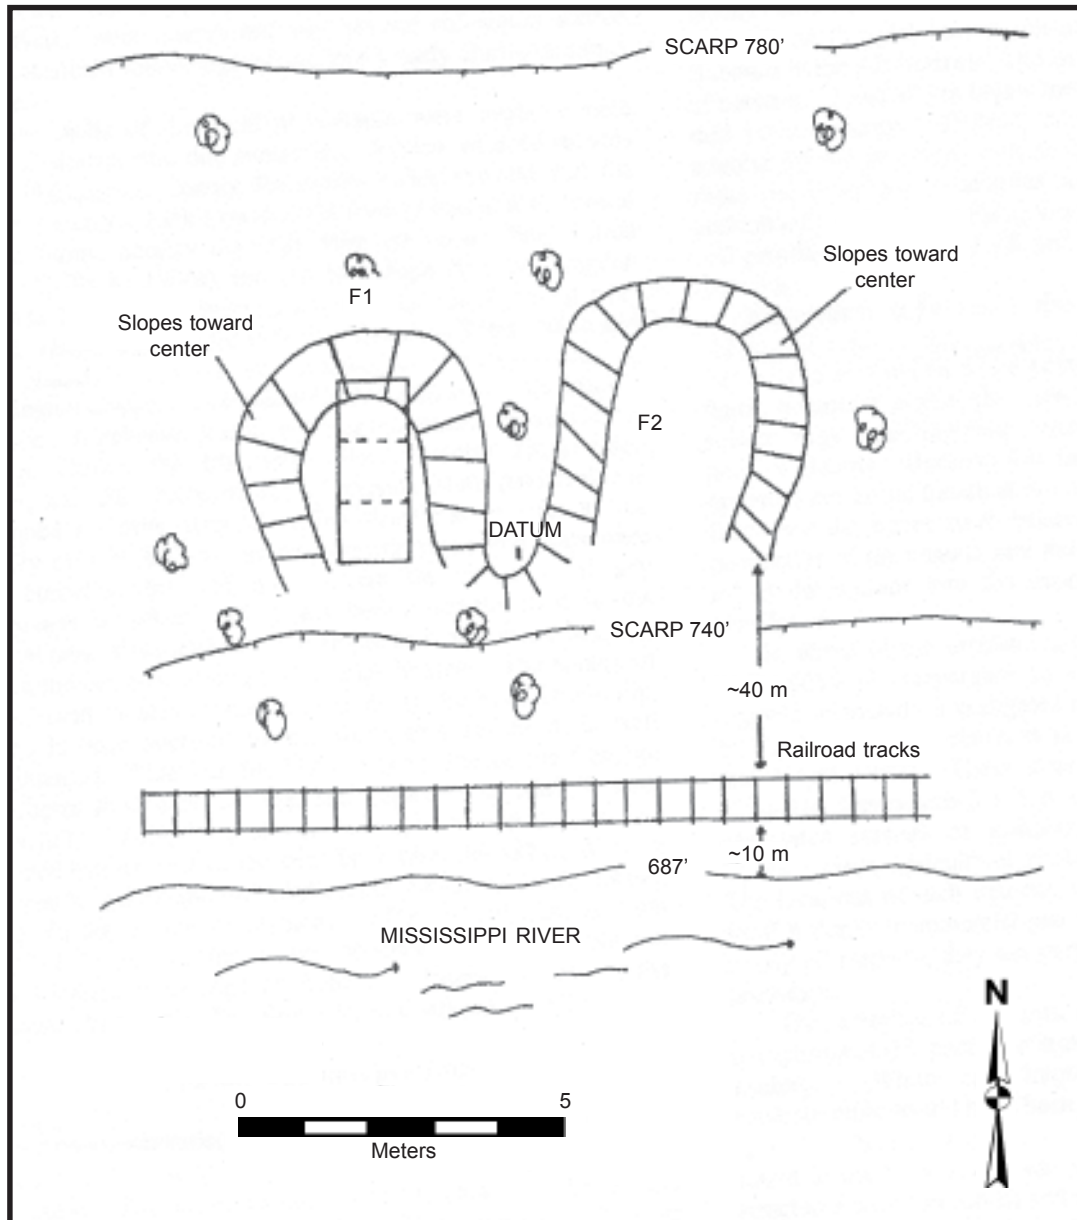
Figure 2.12. Site plan of the Rick Lewis dugout site (21WA55) (from Vogel and Stanley 1993:63).

The Rick Lewis dugout site (21WA55) overlooks the Mississippi River in Washington County. The site consists of three depressions “scooped out of the side of a steep south facing slope” (Vogel and Stanley 1993:61) (Figure 2.12).

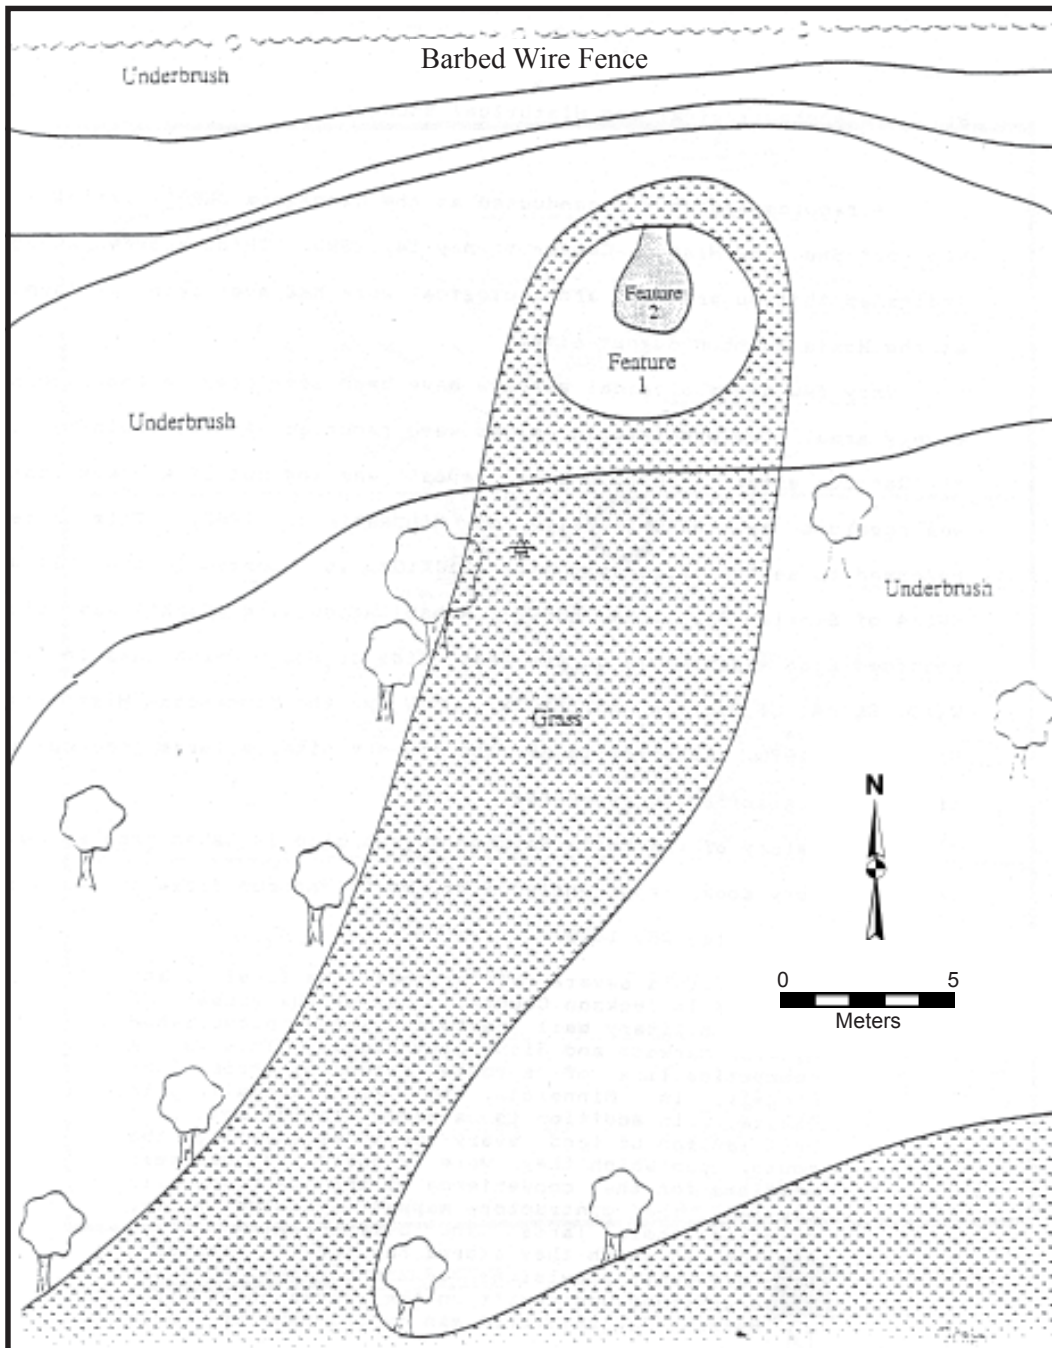
Figure 2.13. Site plan of the Hoxie Rathbun dugout site (21JK22) (from Kapler 1990:6).

The Hoxie Rathbun dugout site (21JK22) was identified as a circular depression perched on a hillside above the Des Moines River in Jackson County (Kapler 1990) (Figure 2.13). The depression measures approximately 20 x 22 ft. (6 x 7 m) and is 6-7 ft. (2 m) deep; a smaller depression was found at the north end or bluff end

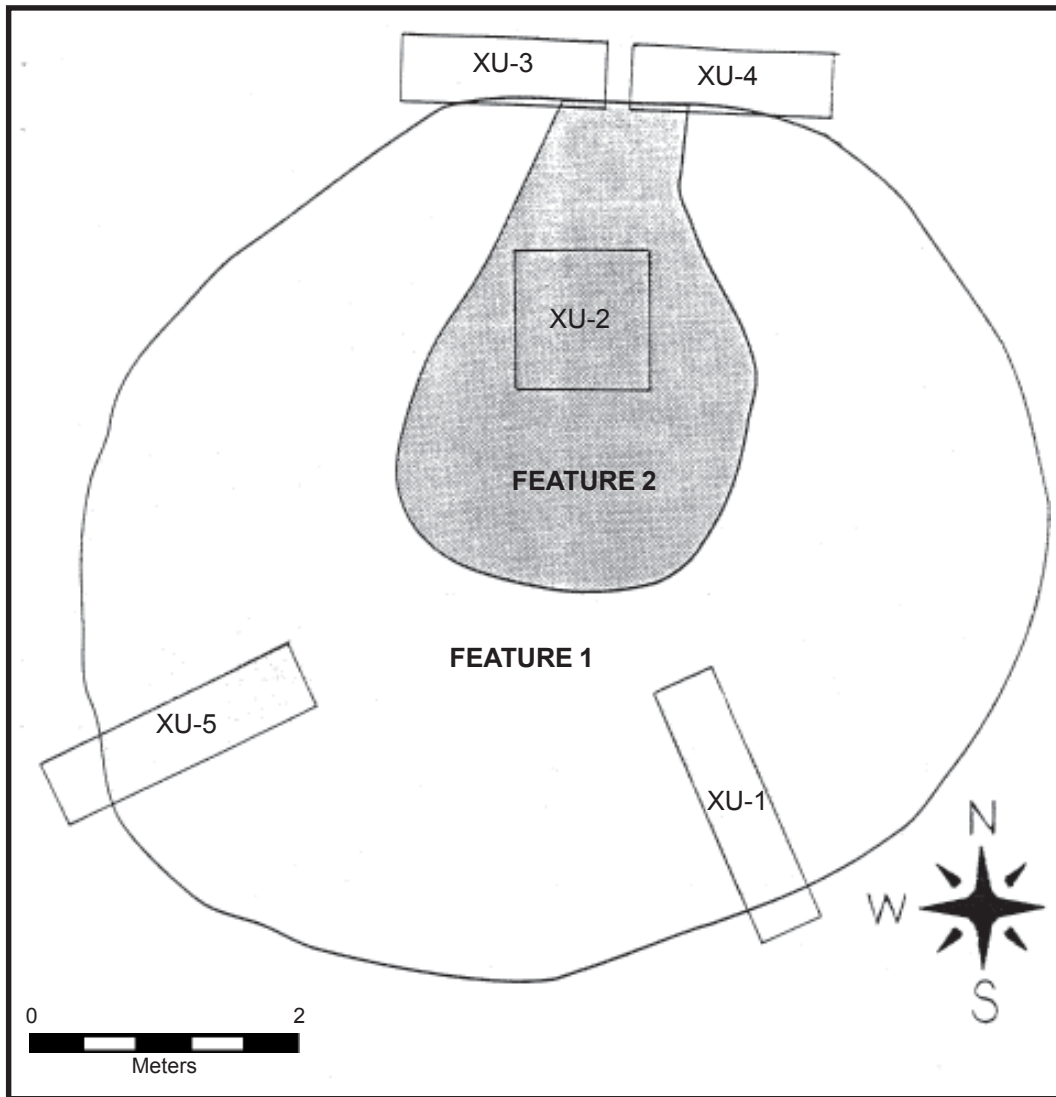
Figure 2.14. Detail plan of the Hoxie Rathbun dugout site (21JK22) (from Kapler 1990:11).

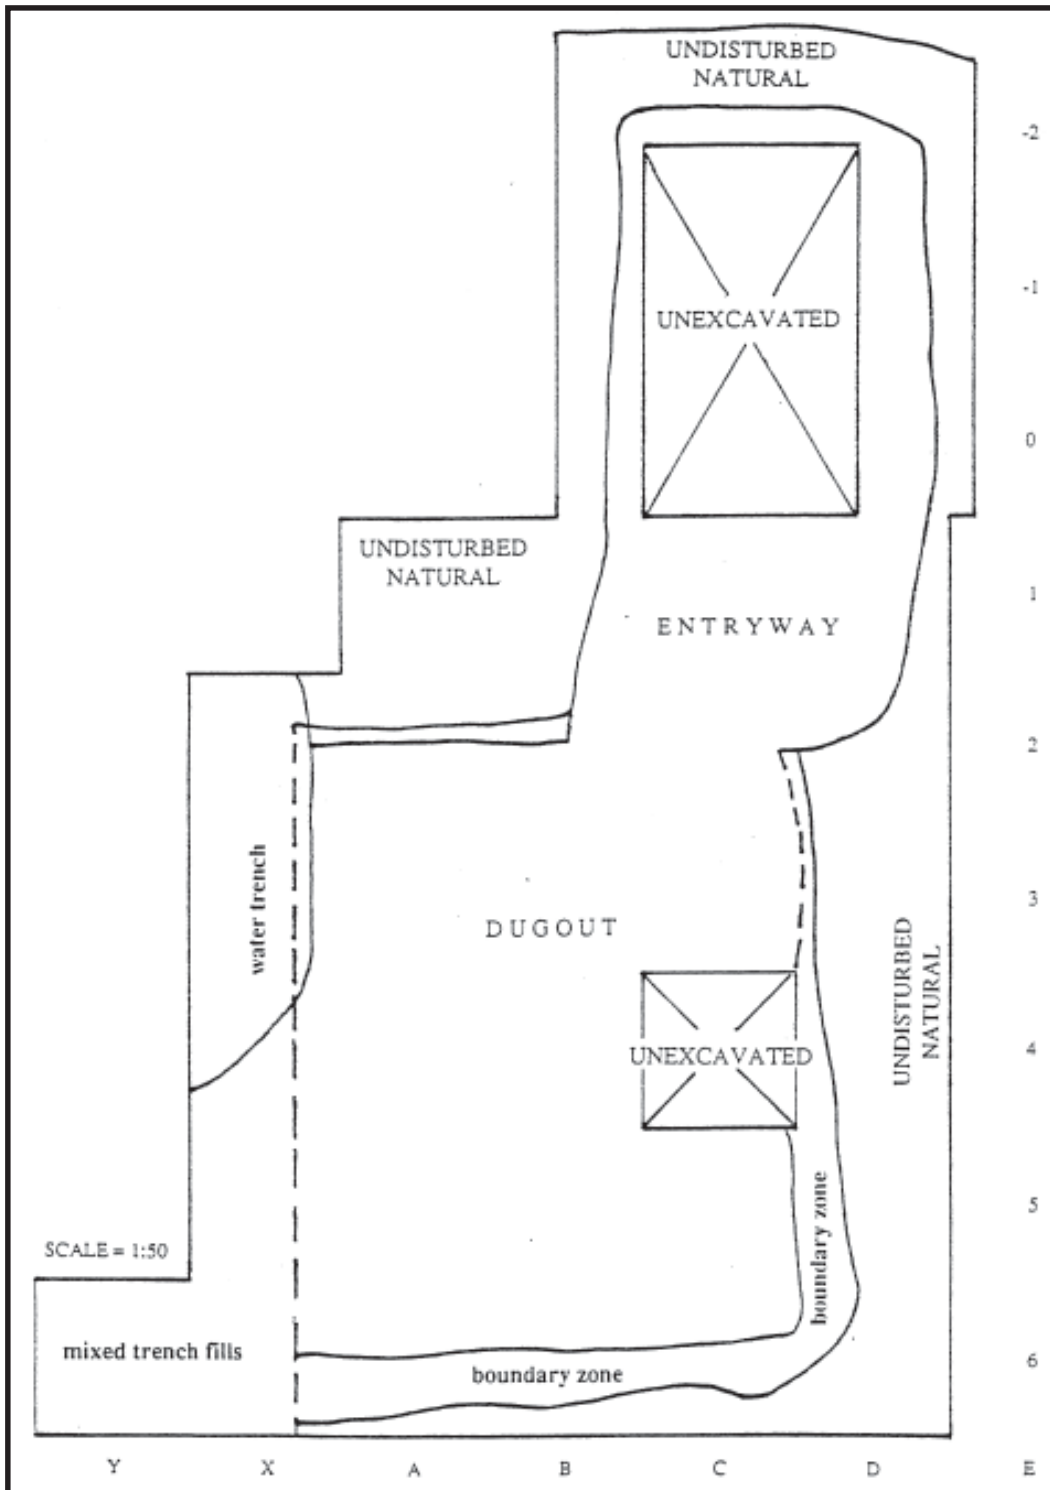
Figure 2.15. Detail plan of the Gibbs Farm dugout (21RA26) (from Blair and Forsberg 1996: Appendix B).

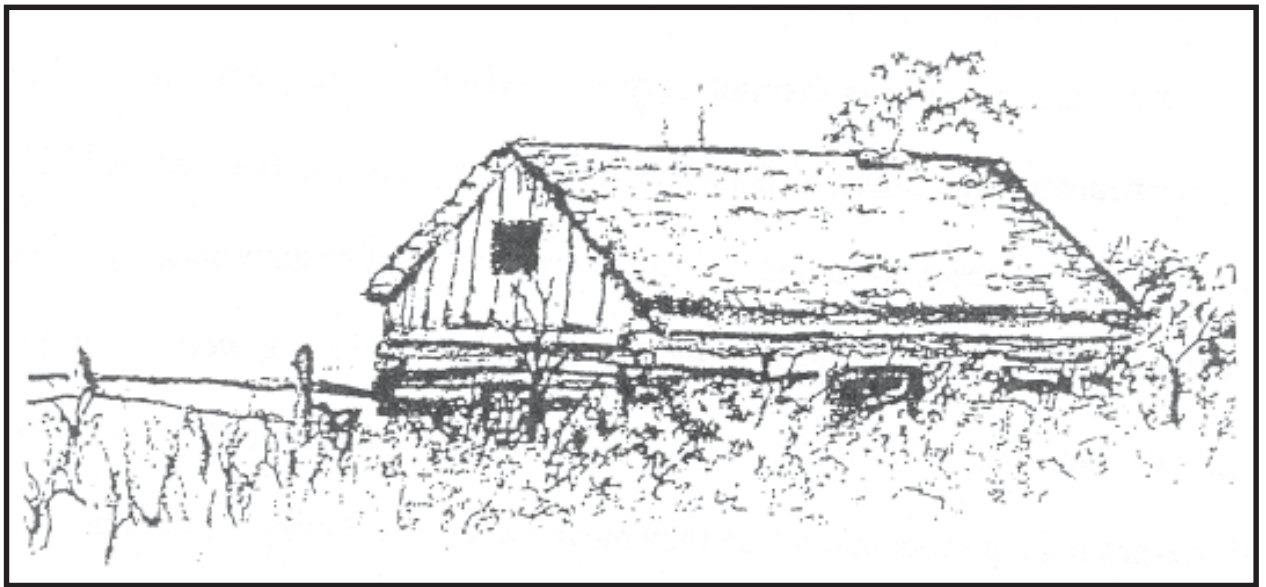
Figure 2.17. Sketch of the Gibbs Farm dugout by Lillie Gibbs, youngest daughter of Heman and Jane Gibbs (from Blair and Forsberg 1996:43).

superstructure. Oral and documentary evidence, including a sketch by daughter Lillie Gibbs, indicates log side walls and a wood framed or log, gable roof (Figure 2.17). A single door was located in the northeastern corner, and the size of the dugout hole suggested to investigators that the internal height may have been 7-9 ft. (Blair and Forsberg 1996:42). Several fragments of window

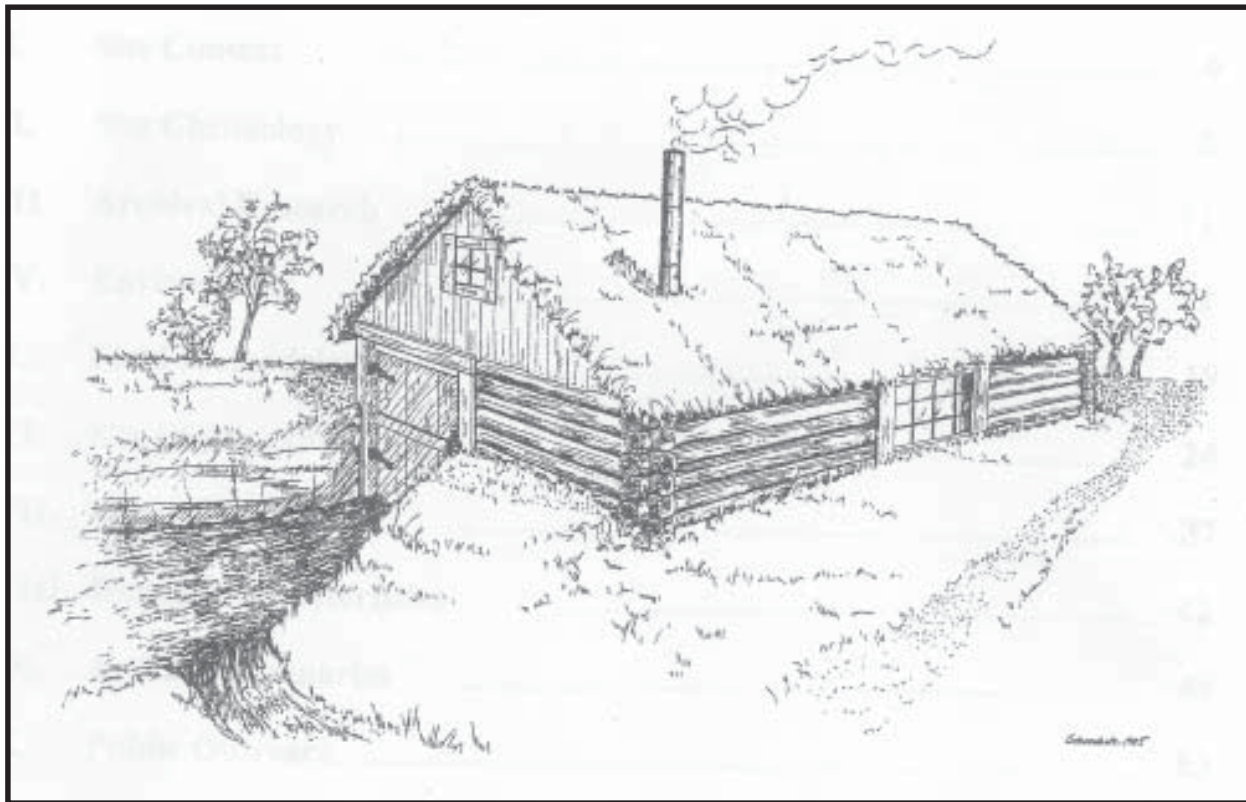
Figure 2.18. Artist’s conjectural reconstruction of the Gibbs Farm dugout (from Blair and Forsberg 1996:3).

The Gibbs dugout was a fairly substantial structure with a wood floor and glass window(s) that was used for a period of about 5 years (Figure 2.18). While it is easy to picture the Gibbs’s life in the dugout as uncomfortable and miserable, the authors note that the archaeology suggests several mitigating factors. The loose sand and gravel layer at the base of the dugout depression provided excellent drainage. The house also had a raised wood plank floor that certainly improved living conditions. Finally, the presence of several tacks

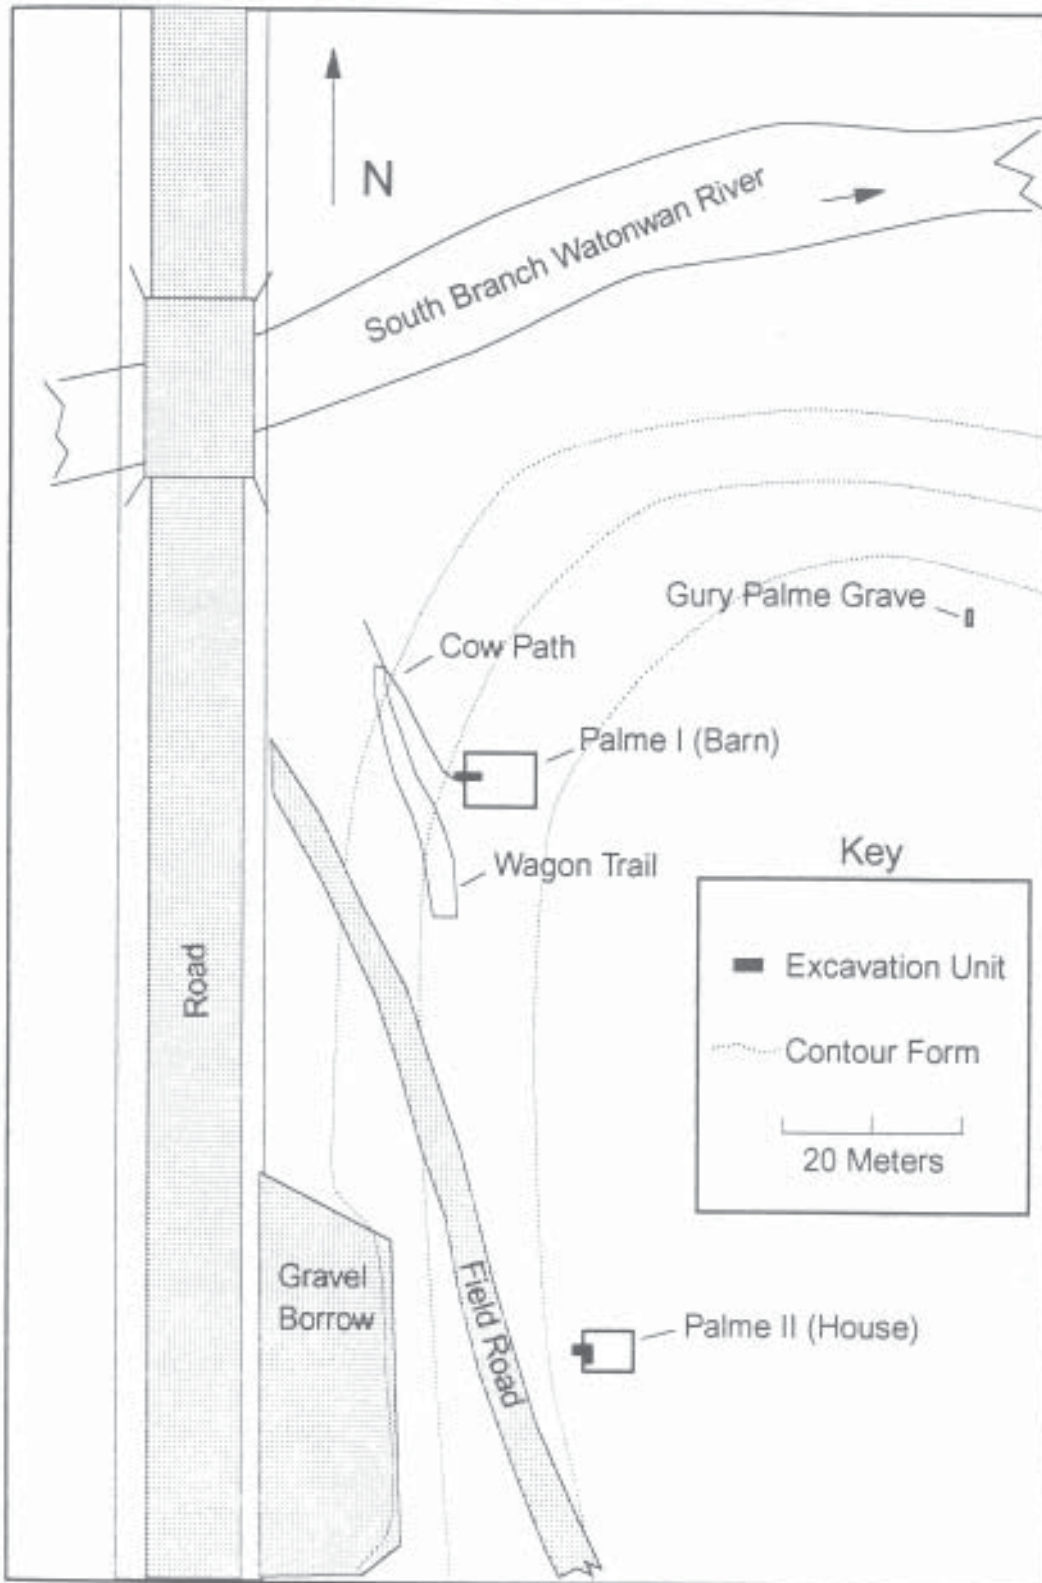
Figure 2.19. Site plan of the Ole Palme dugouts (from Broste 1995:188).

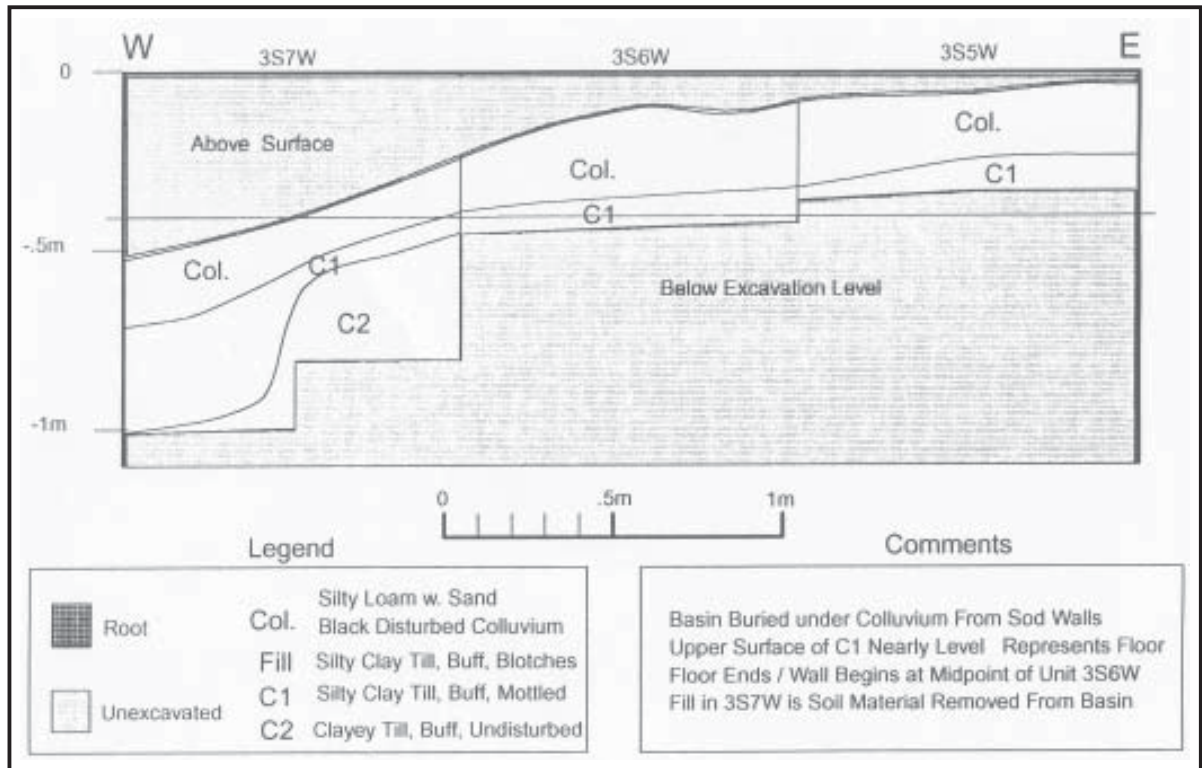
Figure 2.20. North profile of Palme I dugout (from Broste 1995:193).

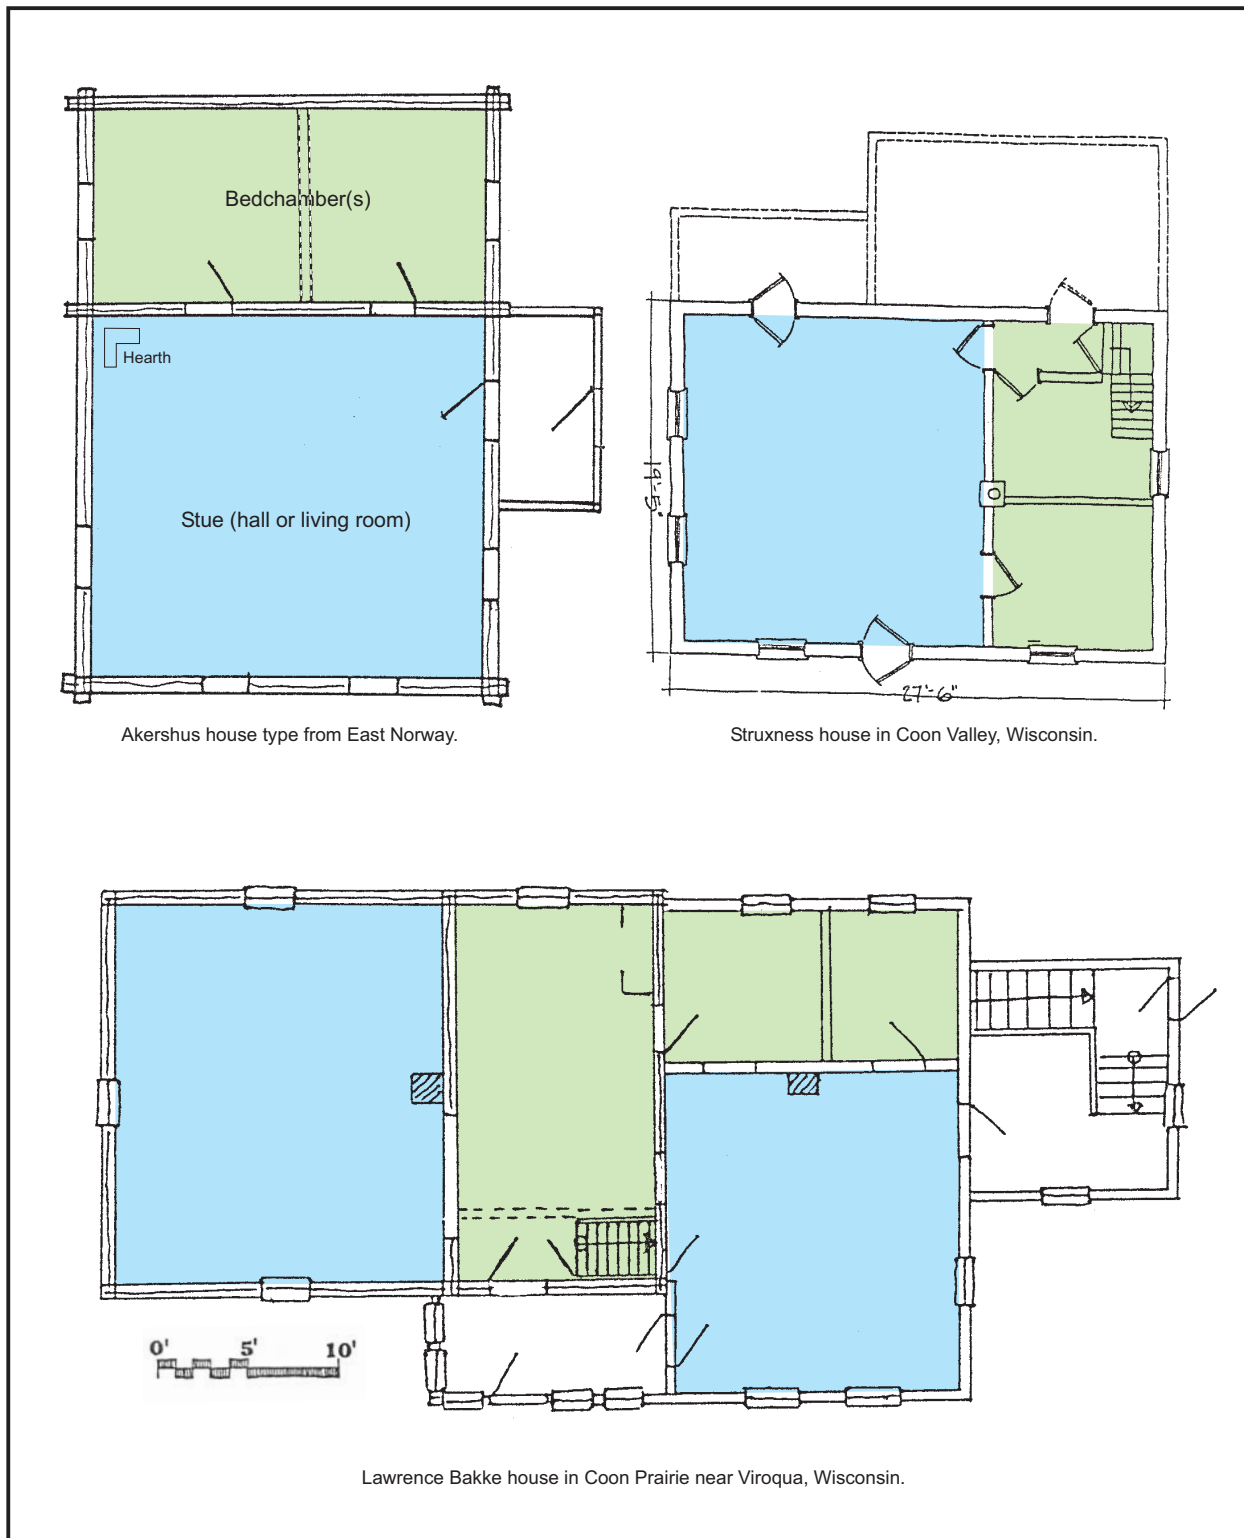
Figure 2.22. Floor plan of the Akershus house type and several examples of similar plans in Wisconsin (after Bakken 1994:77, 80).

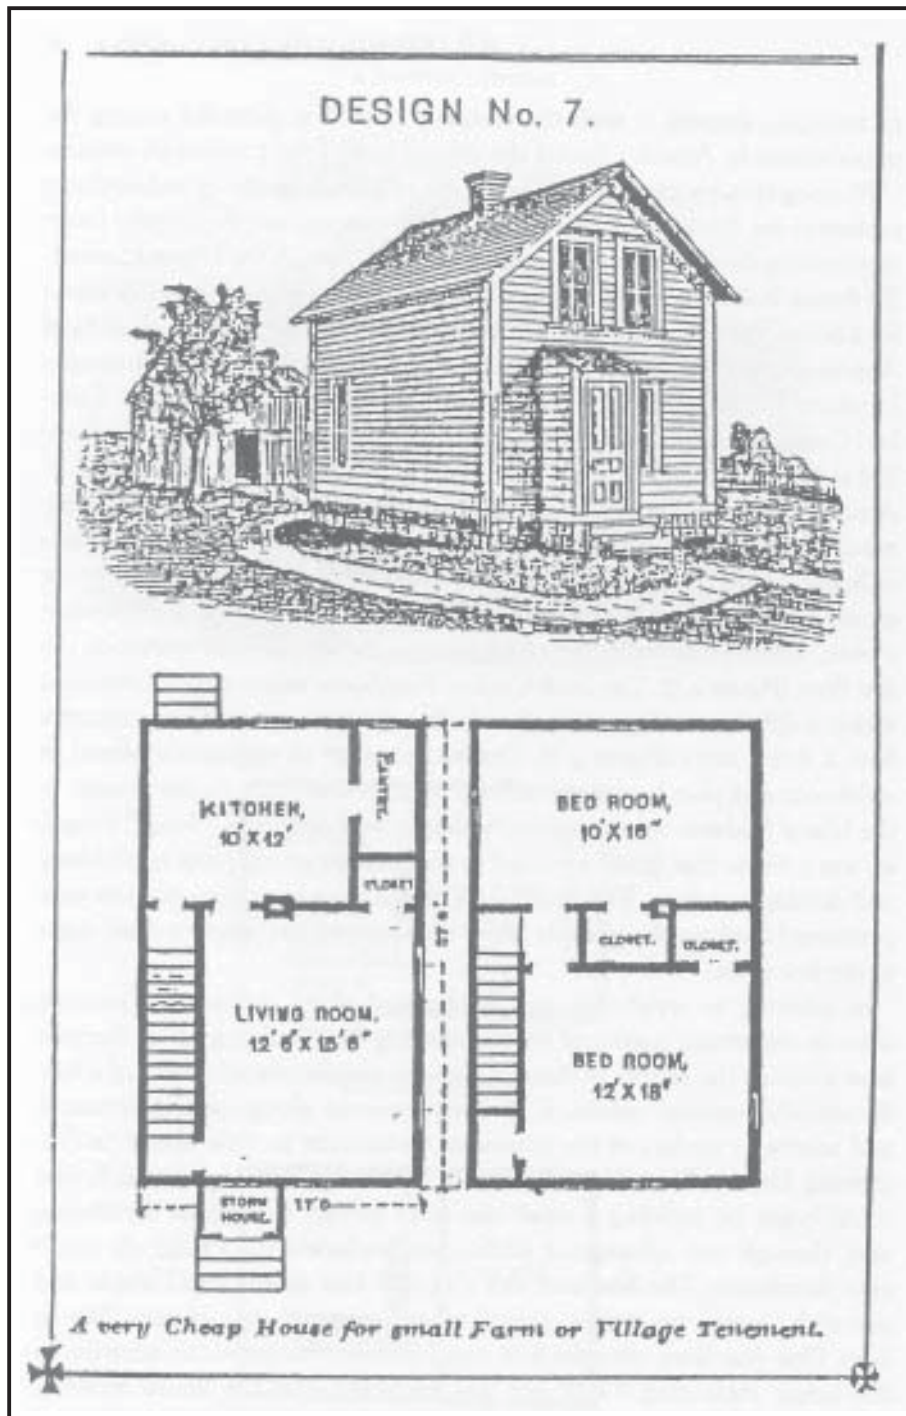
Figure 2.24. "Design No. 7: A very cheap house for small farm or village tenement" (from Adams-Horr Company, Rural Architecture [Chicago: Northwestern Lumberman Print, 1884]).

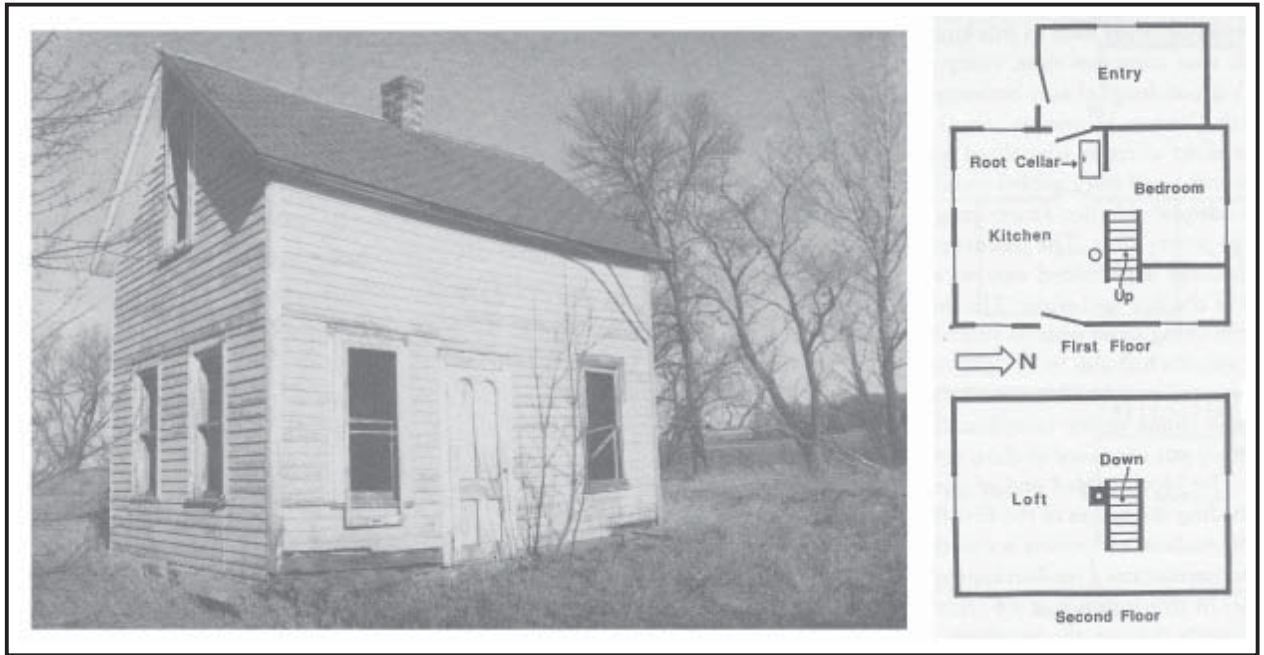
Figure 2.25. Farmhouse type I, Pope County, MN, ca. 1870 (Peterson 1992:65).

The simplest of these structures, and that most like the Goulson’s frame farmhouse, is Farmhouse Type I. This “one- to one-and-a-half-story rectangular volume enclosed by exterior walls and covered by a saddle roof,” writes Peterson (1992:27), “usually lends itself to only two interior spaces on the first floor and the half story divided more or less equally at or near the middle of the longer side of the rectangle.” The Type I Farmhouse includes examples of the very smallest and simplest of the structures found in the region. Peterson (1992:62) notes that the “one- to one-and-a-half-story gabled rectangular farmhouse was frequently the kind of affordable structure built when circumstances permitted the family to move from the temporary subsistence shelter to a more permanent dwelling.” The change represented a significant move from the one room interior of a

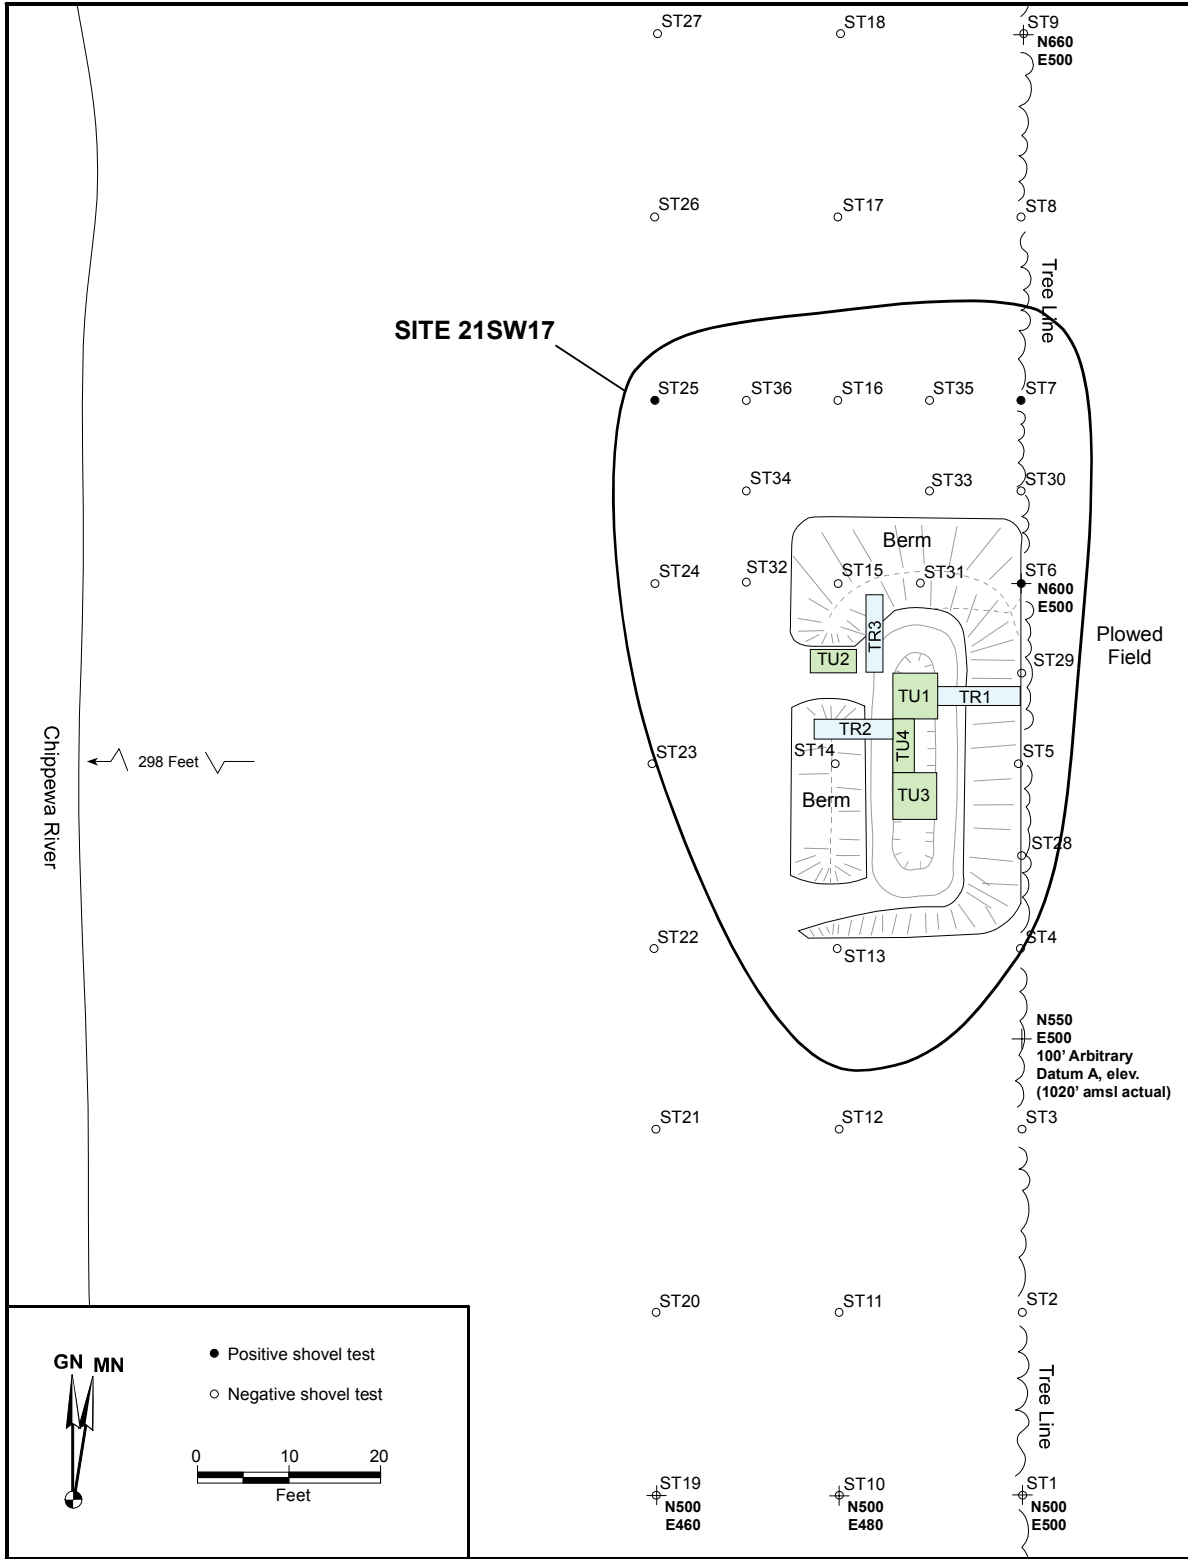
Figure 3.2. Plan of Site 21SW17 showing shovel test units.

Only three artifacts were recovered during the shovel test survey. Shovel Test 7 contained a cut nail, Shovel Test 6 contained a ferrous metal knife handle, and Shovel Test 25 contained a possible fragment of mortar. None of these materials is extremely diagnostic, although the knife handle appears to be a late nineteenth-century type with wood handles and the cut nail would date generally between 1790 and 1880. The shovel testing work at the dugout site did not provide enough artifacts to suggest concentrations of materials that might reflect activity areas; all of the positive shovel tests were close to the dugout depression.
