**DIGGING INTO A DUGOUT HOUSE (SITE 21SW17):
THE ARCHAEOLOGY OF NORWEGIAN IMMIGRANT
ANNA BYBERG CHRISTOPHERSON GOULSON,
SWENODA TOWNSHIP, SWIFT COUNTY, MINNESOTA**

Technical Report No. 480

May 2003

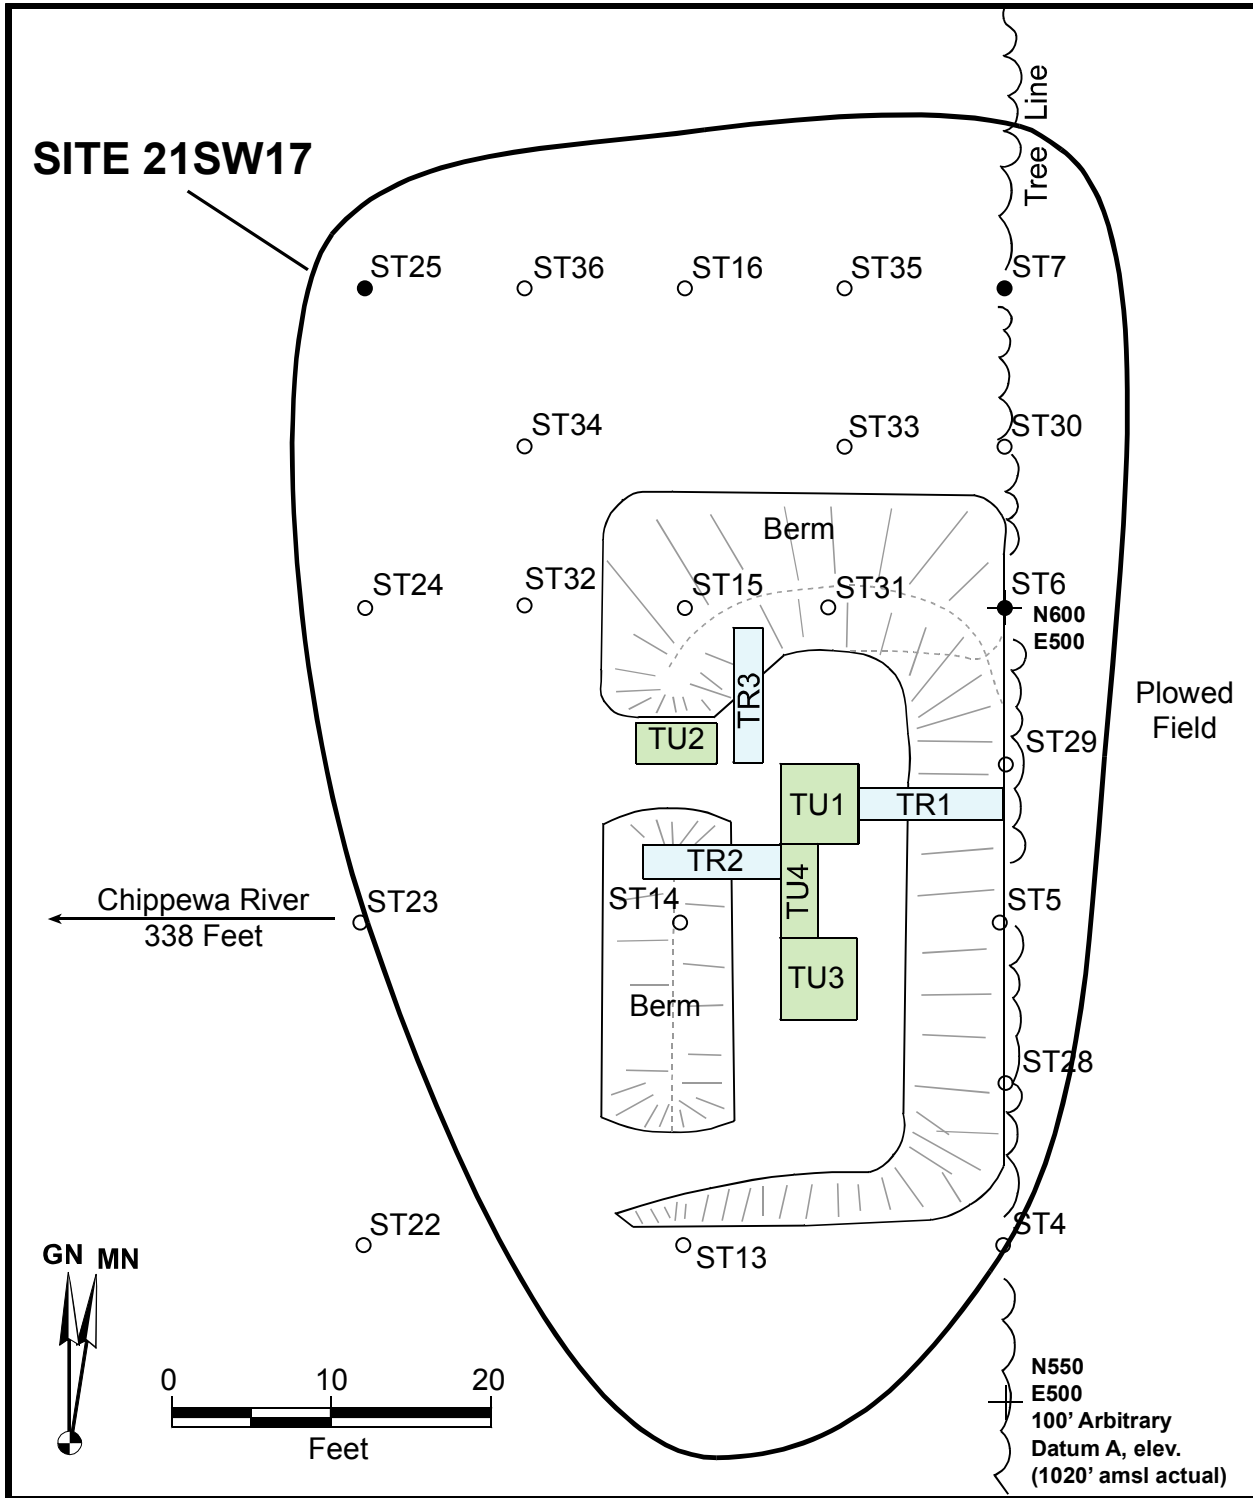
Figure 3.7. Detail plan of Site 21SW17 showing test units (TU) and trenches (TR).

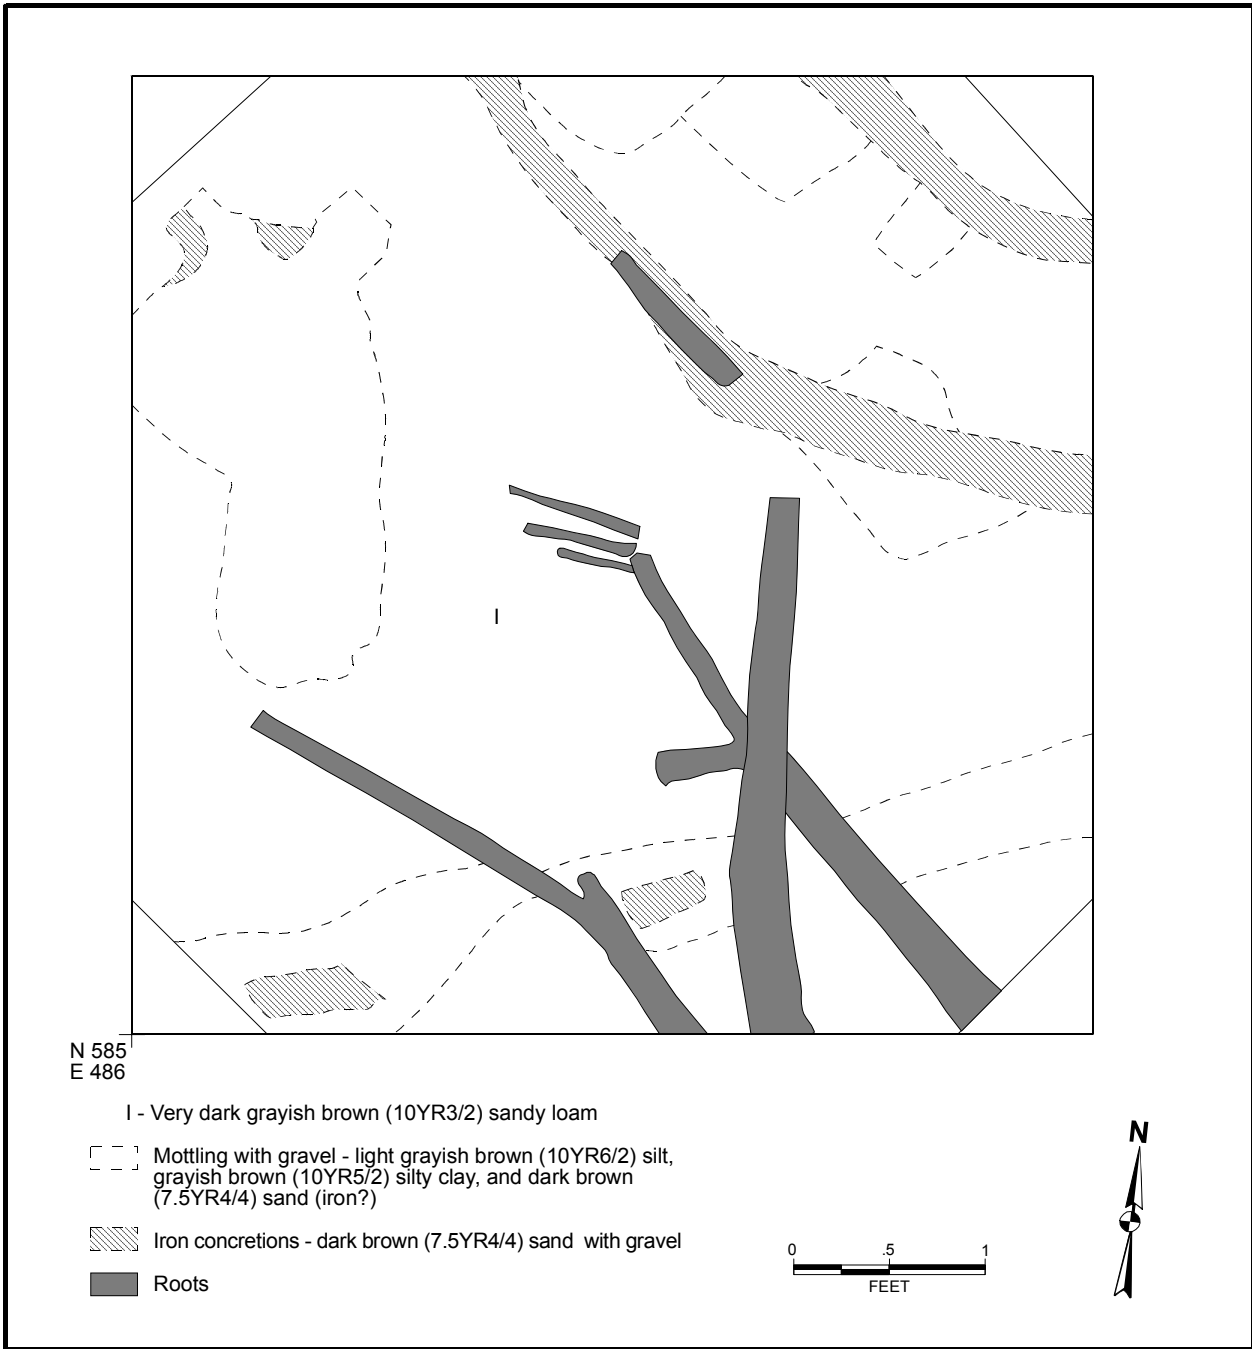
Figure 3.9. Plan of Test Unit 1, bottom of Level IV.

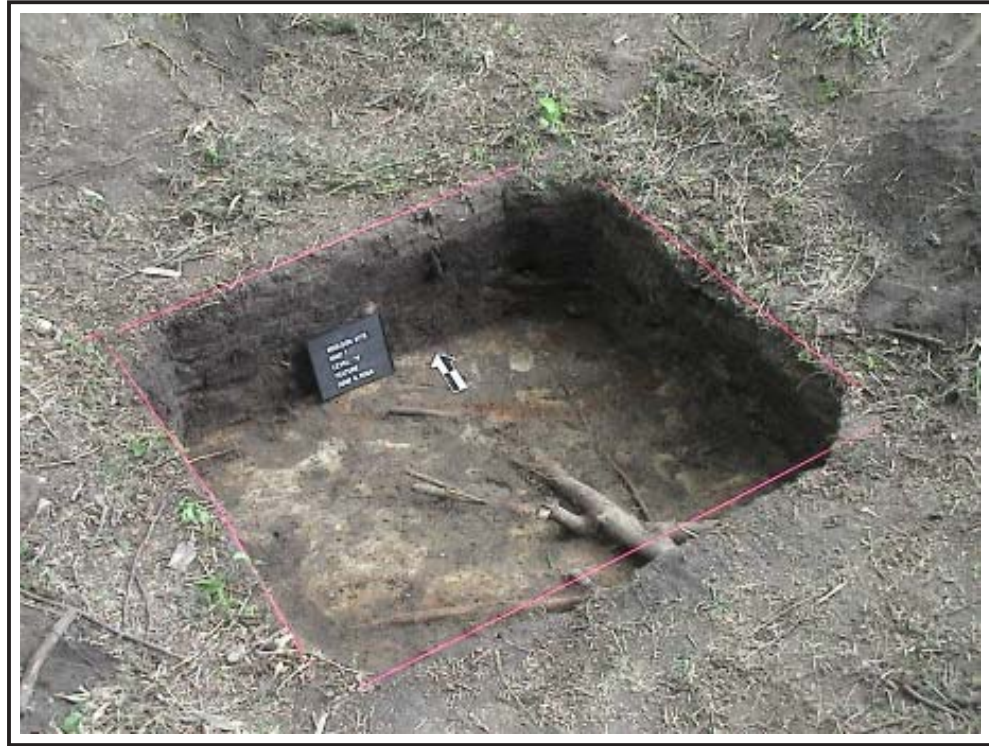
Figure 3.10. Test Unit 1, bottom of Level IV, note iron concretion staining.

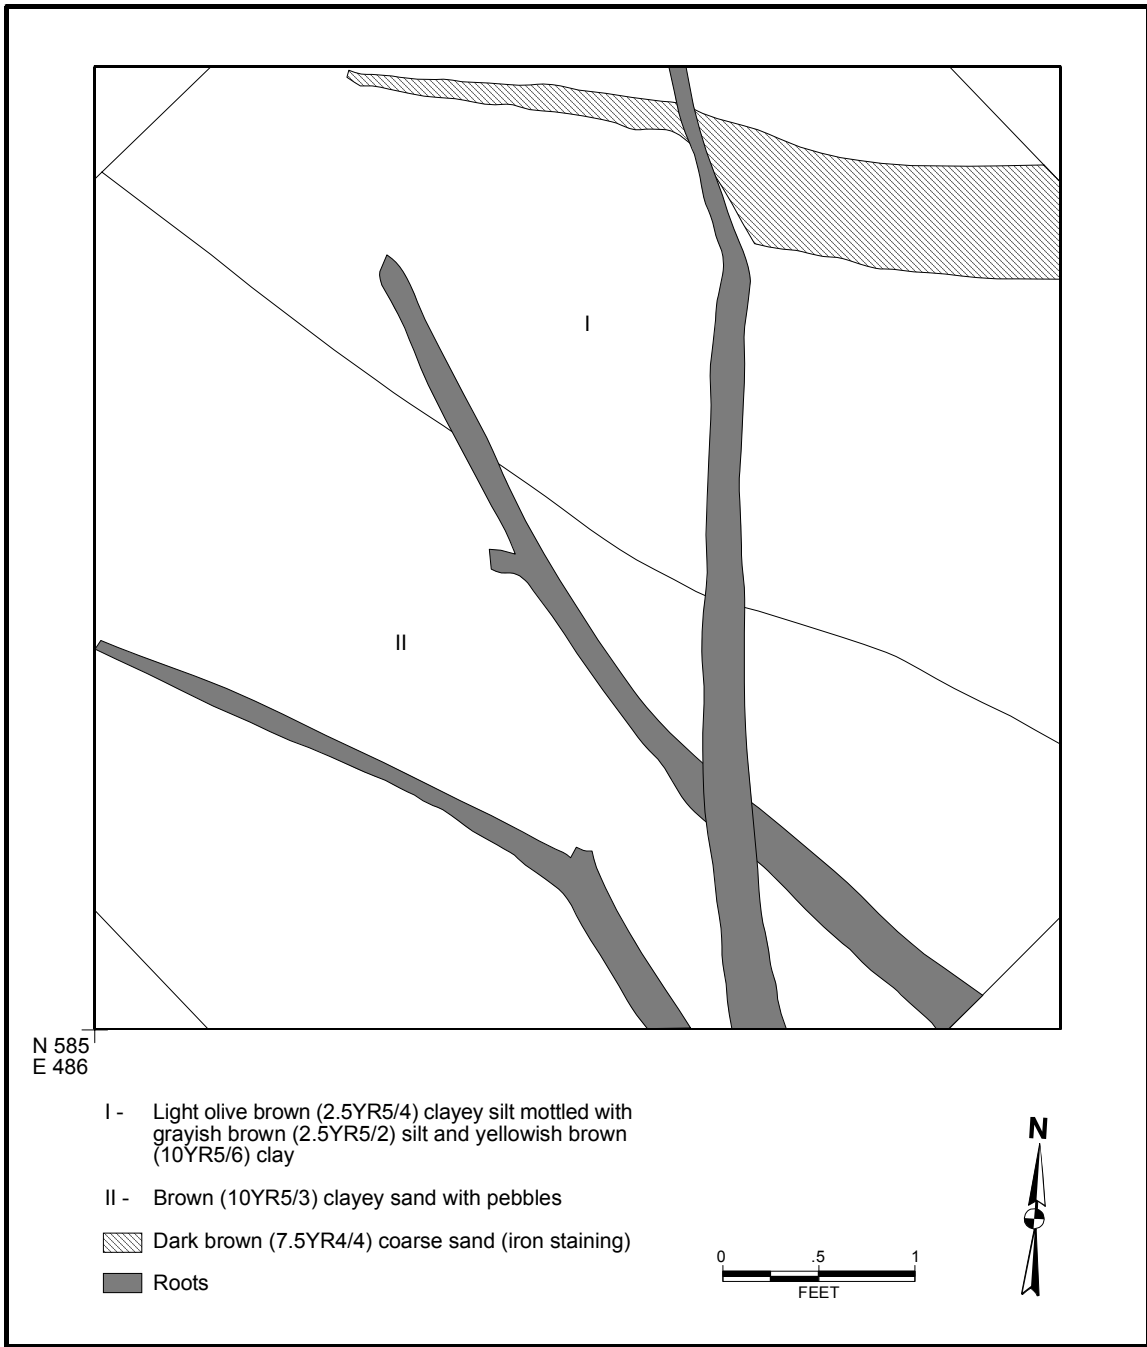
Figure 3.11. Plan of Test Unit 1, bottom of Level V.

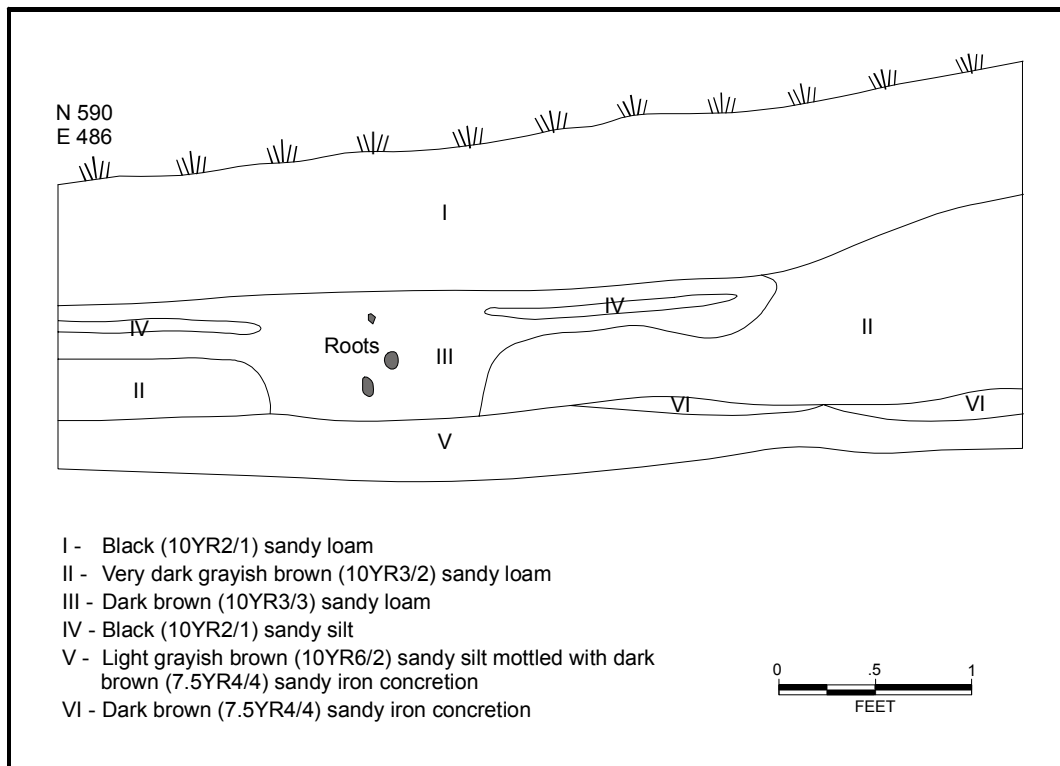
Figure 3.12. North profile of Test Unit 1.

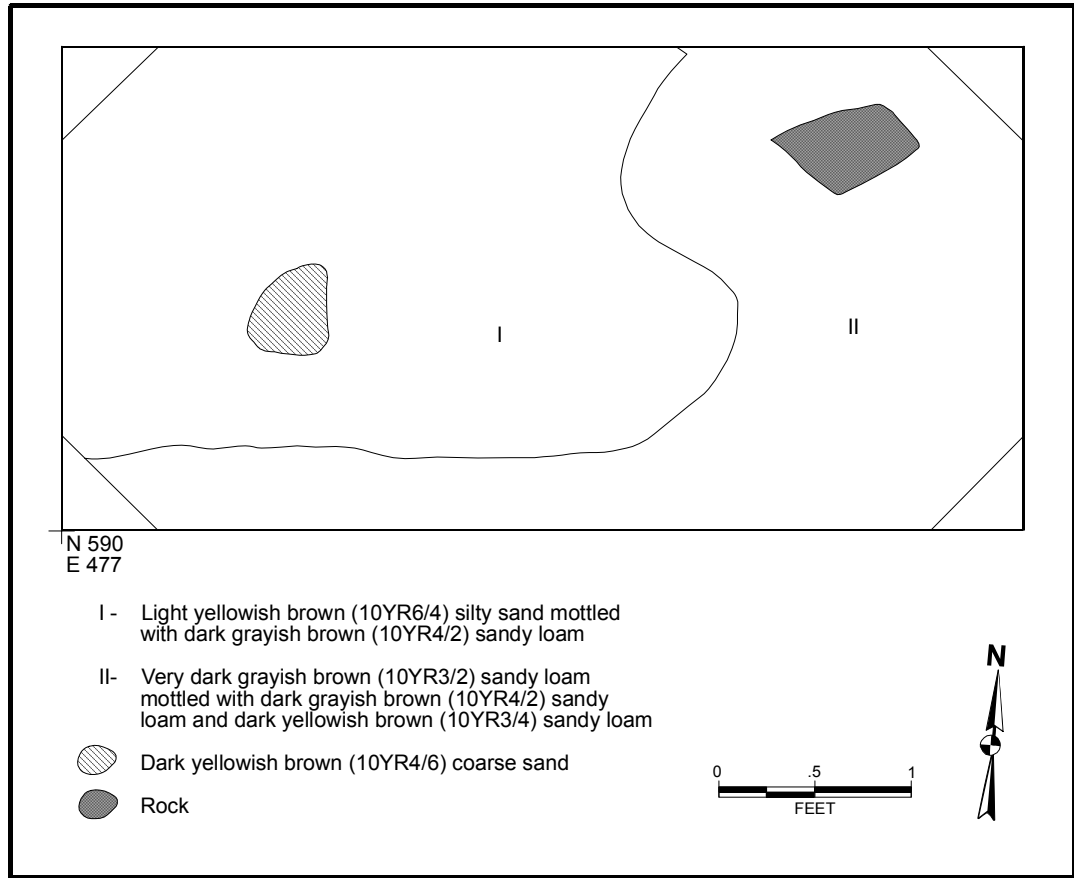
Figure 3.14. Plan of Test Unit 2, bottom of Level VI.

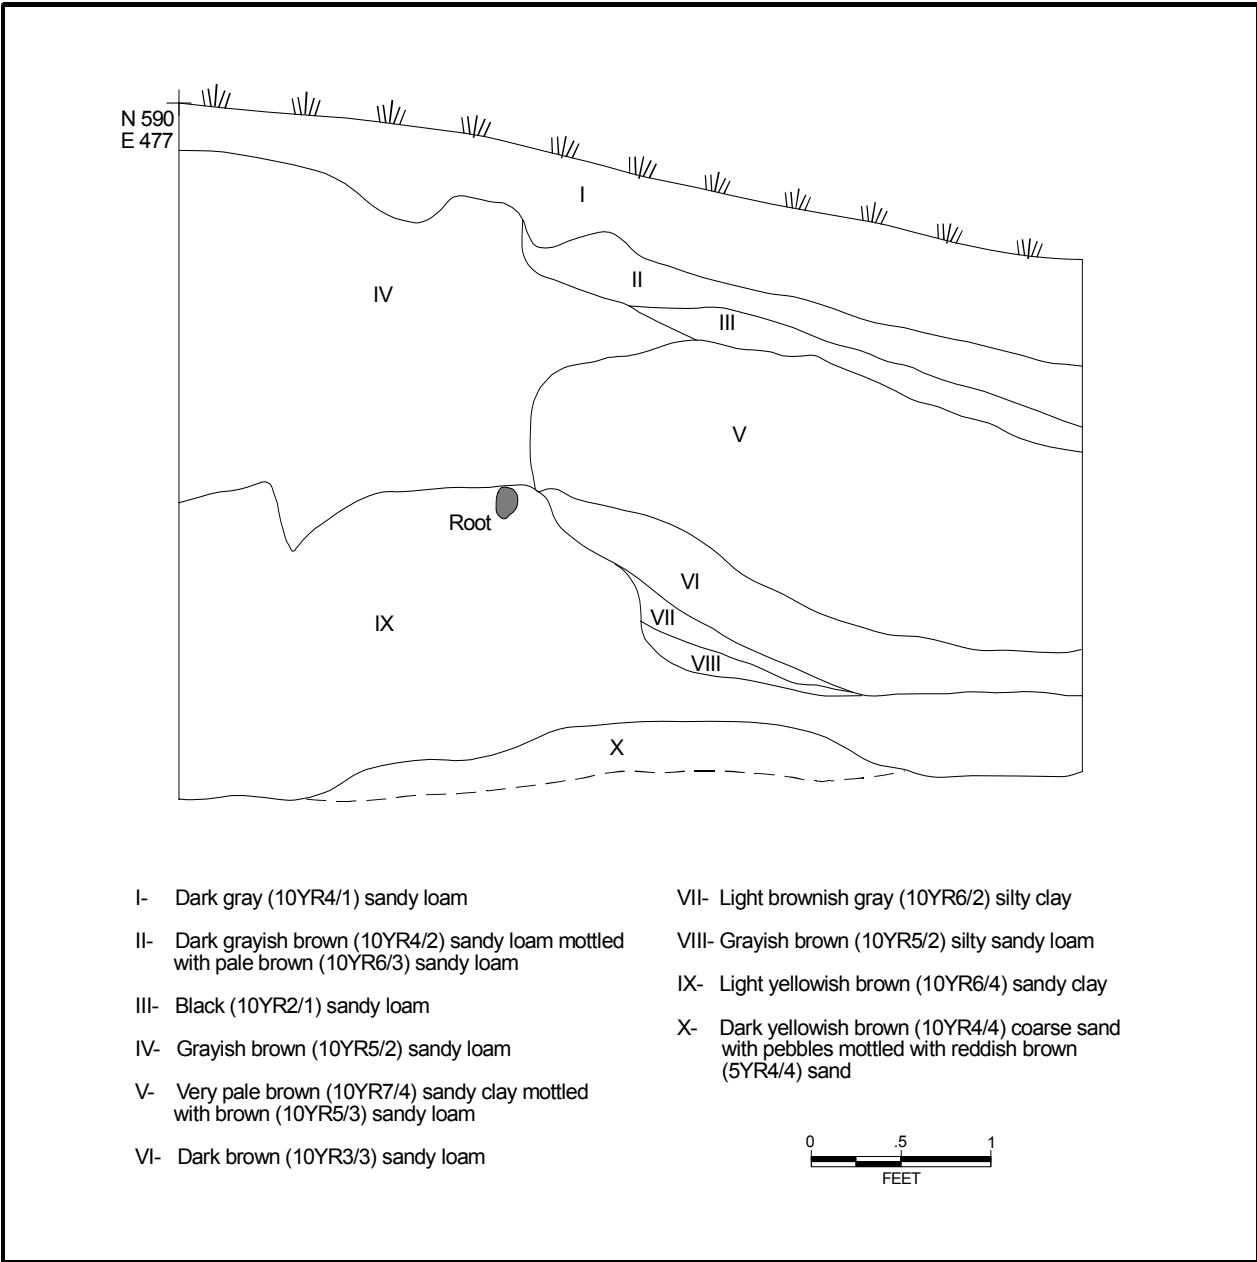
Figure 3.15. North profile of Test Unit 2.

sandy loam mottled with Strata I and II. Stratum IV was a .04-.63 ft. layer of brown (10YR4/3) loamy sand mixed with yellowish brown (10YR5/4) clayey sand with a significant concentration of gravel (Figure 3.14). Stratum V was a .55-.86 ft. layer of brown (10YR5/3) loamy sand, that overlaid a .02-.84 ft. layer of light yellowish brown (10YR6/4) sand (contained primarily in the west 2/3's of the unit) (Stratum VI). Stratum VII was a .37-.74 ft. layer of yellowish brown (10YR5/4) sand with gravel. The north profile of Test Unit 2 clearly indicates the base of the floor and west wall of the dugout cellar; note the thin silted layers marked VI, VII, and VIII in the profile (Figure 3.15). The south profile does not show the same

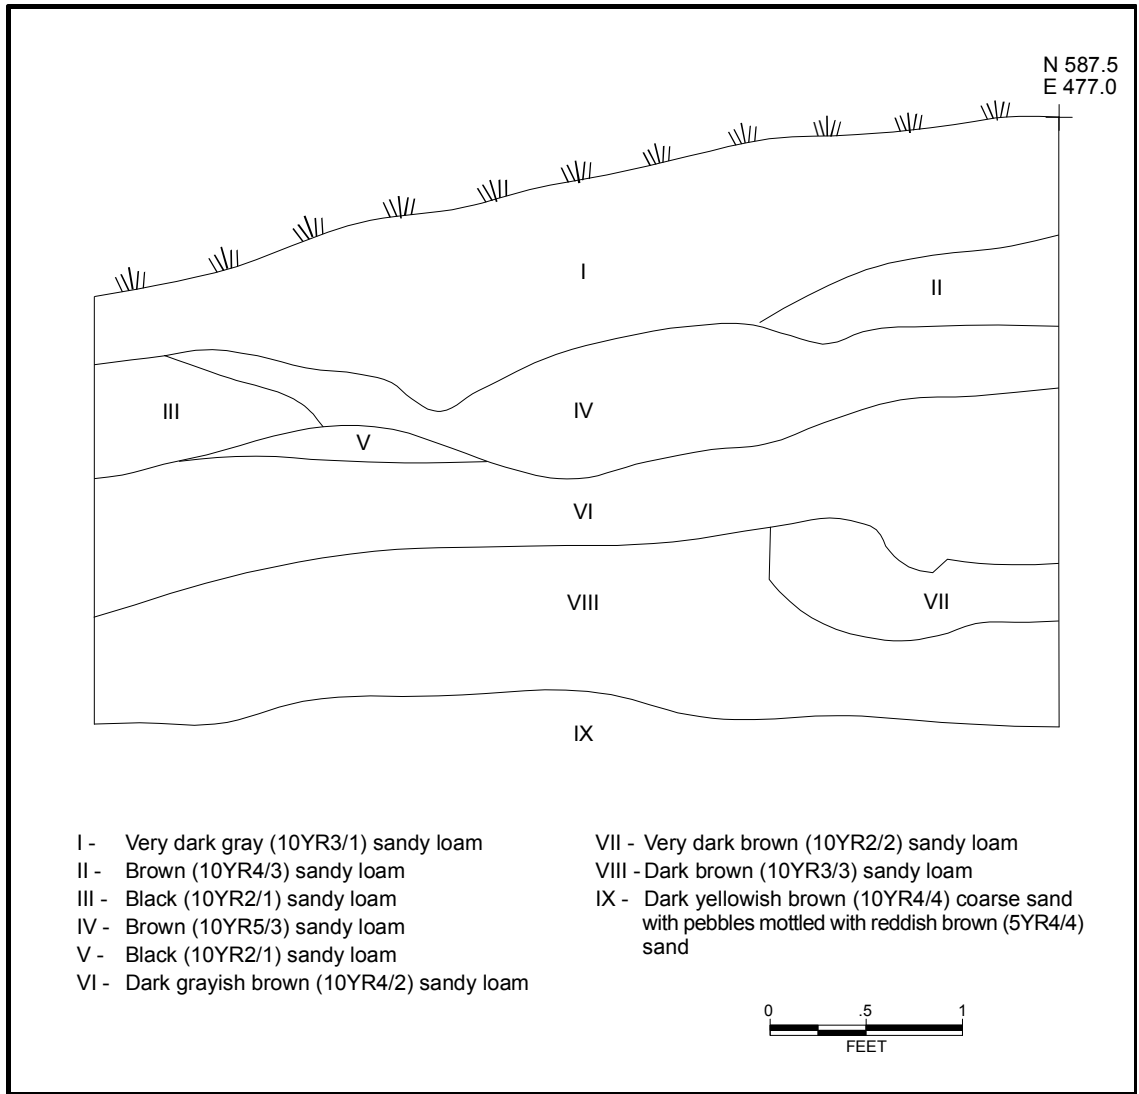
Figure 3.16. South profile of Test Unit 2.

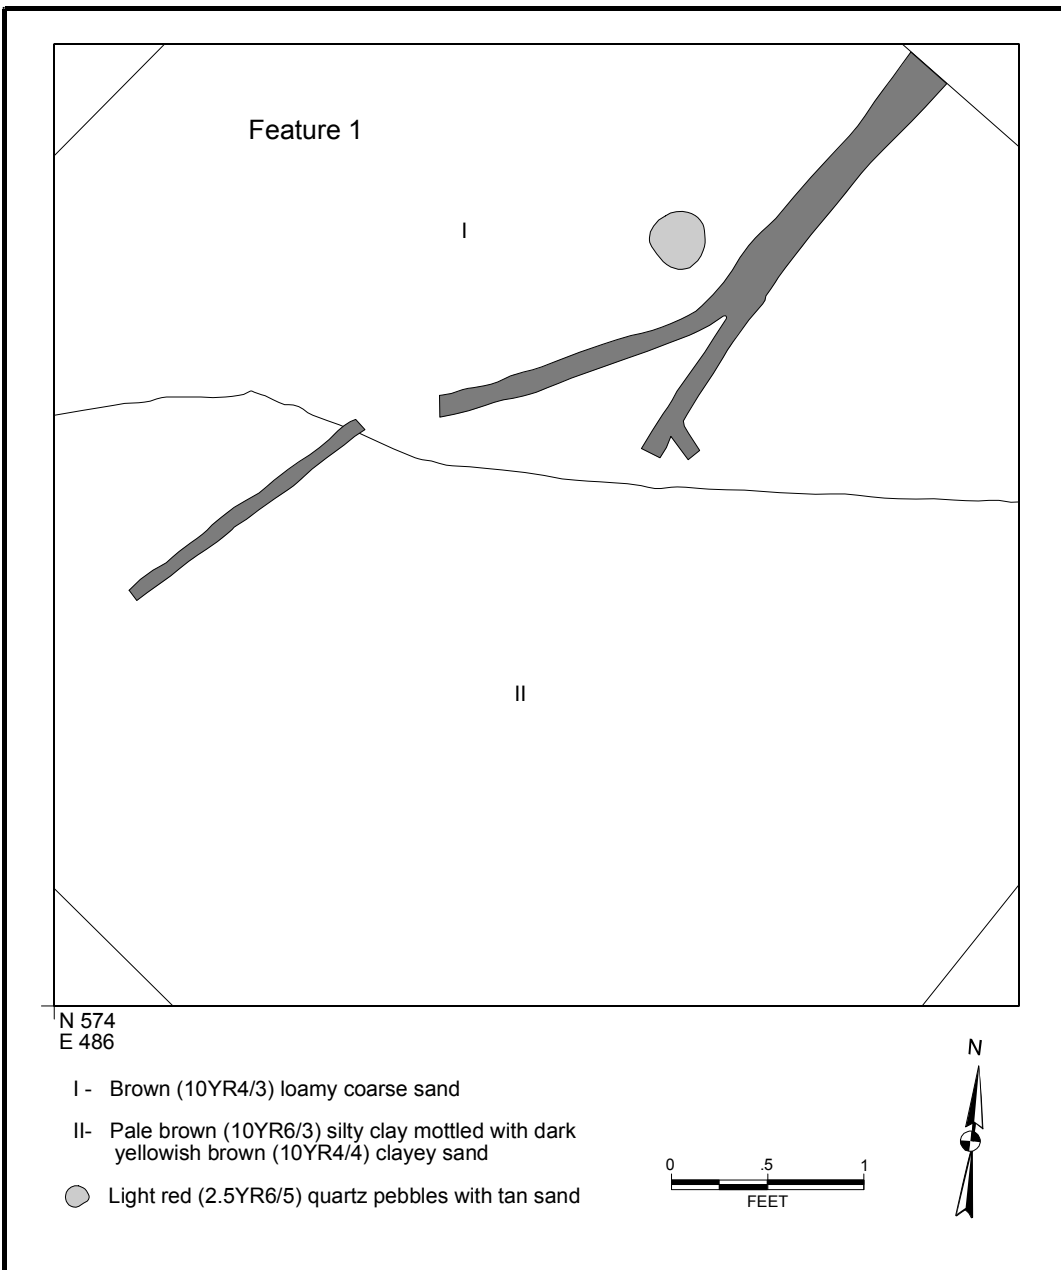
Figure 3.18. Plan of Test Unit 3, bottom of Level IV.

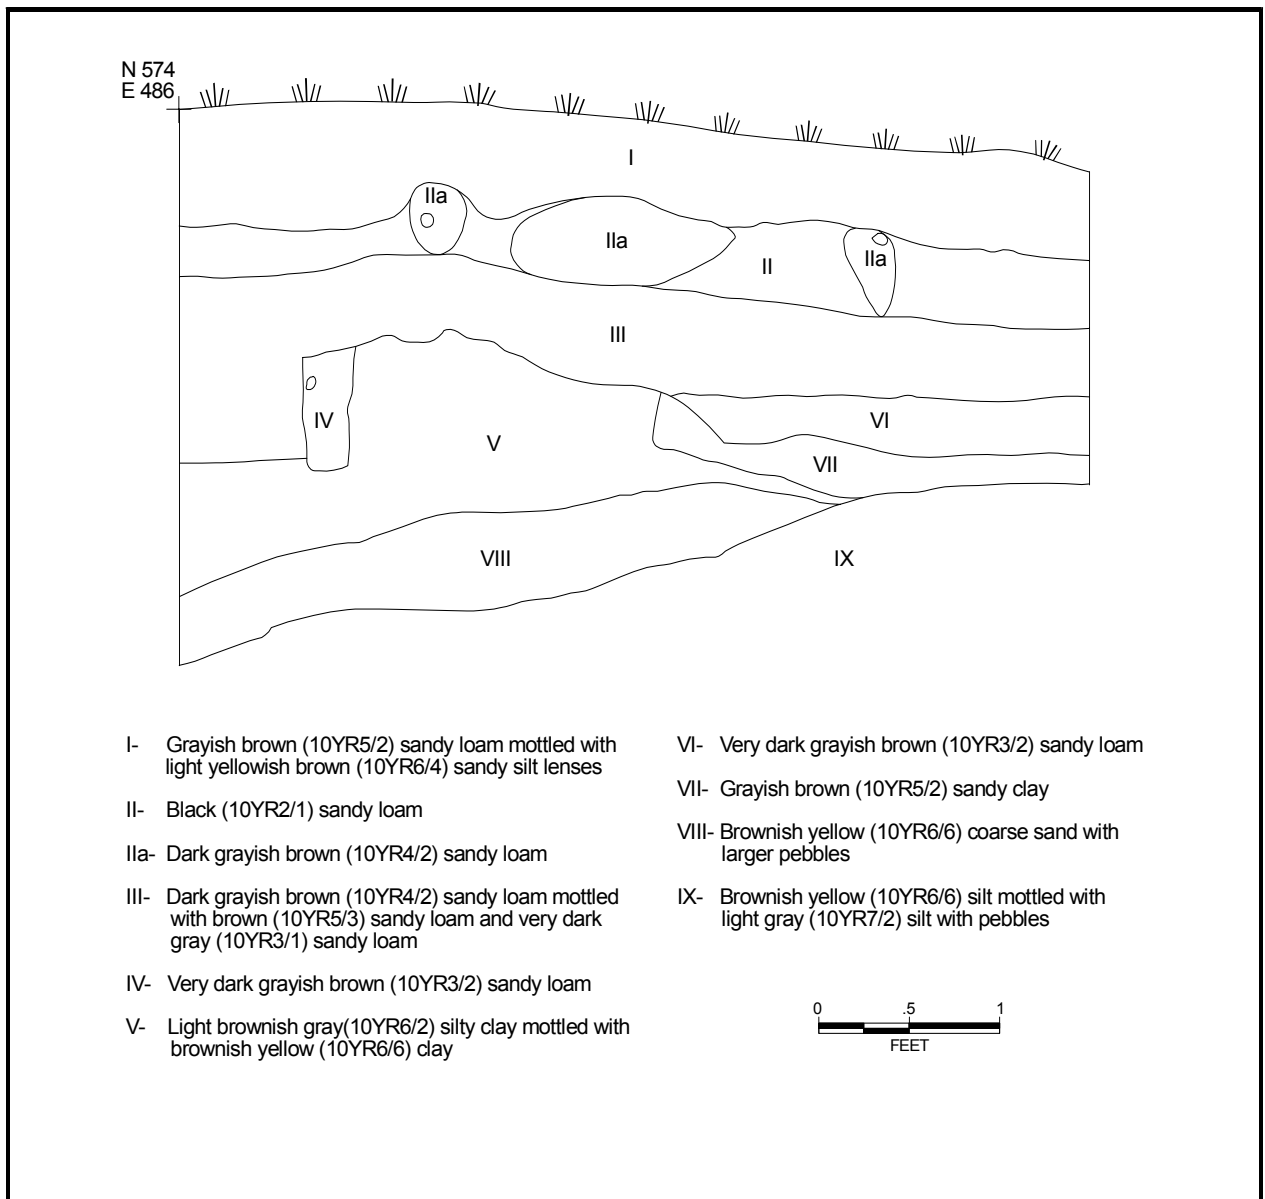
Figure 3.19. West profile of Test Unit 3.

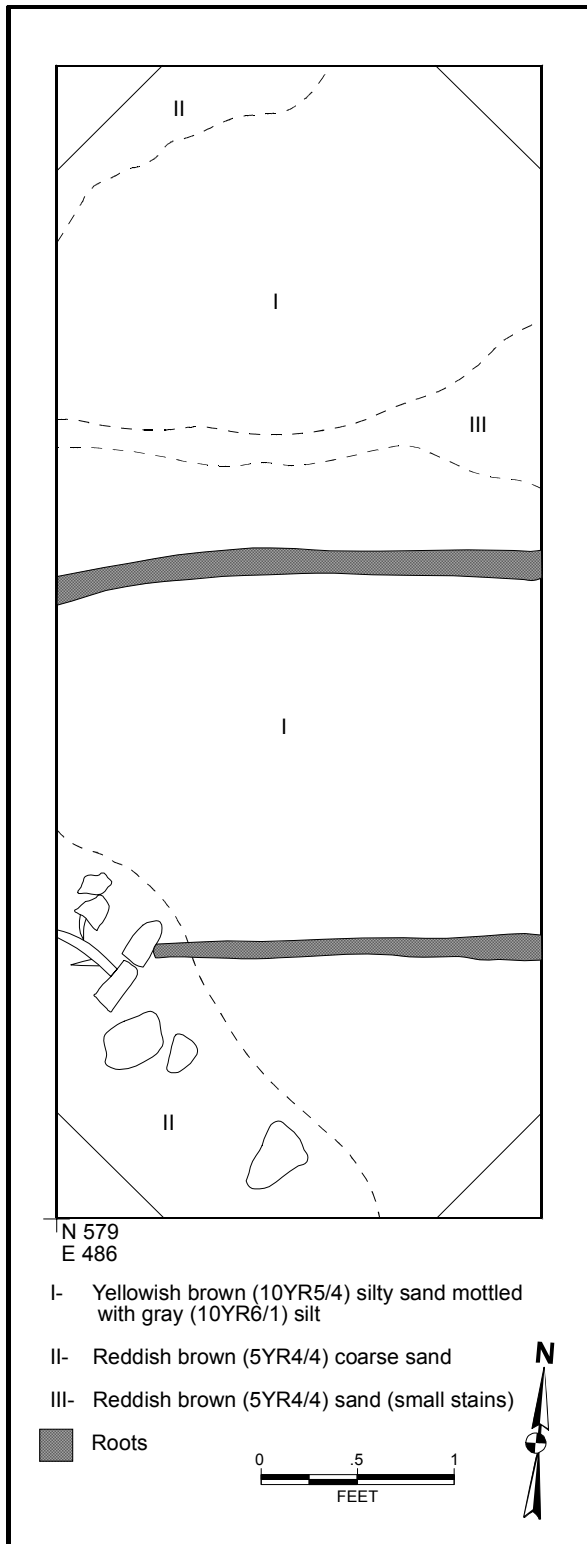
Figure 3.20. Plan of Test Unit 4, bottom of Level III.

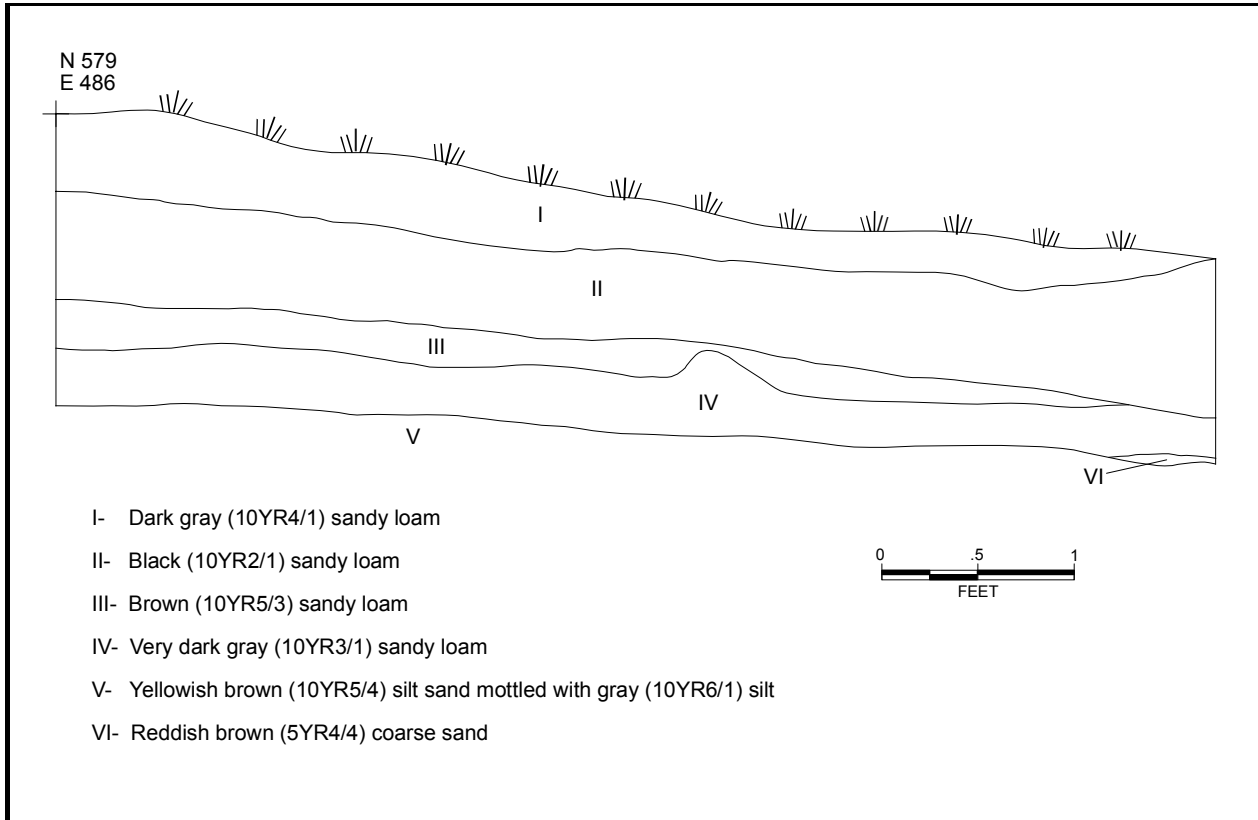
Figure 3.21. West profile of Test Unit 4.

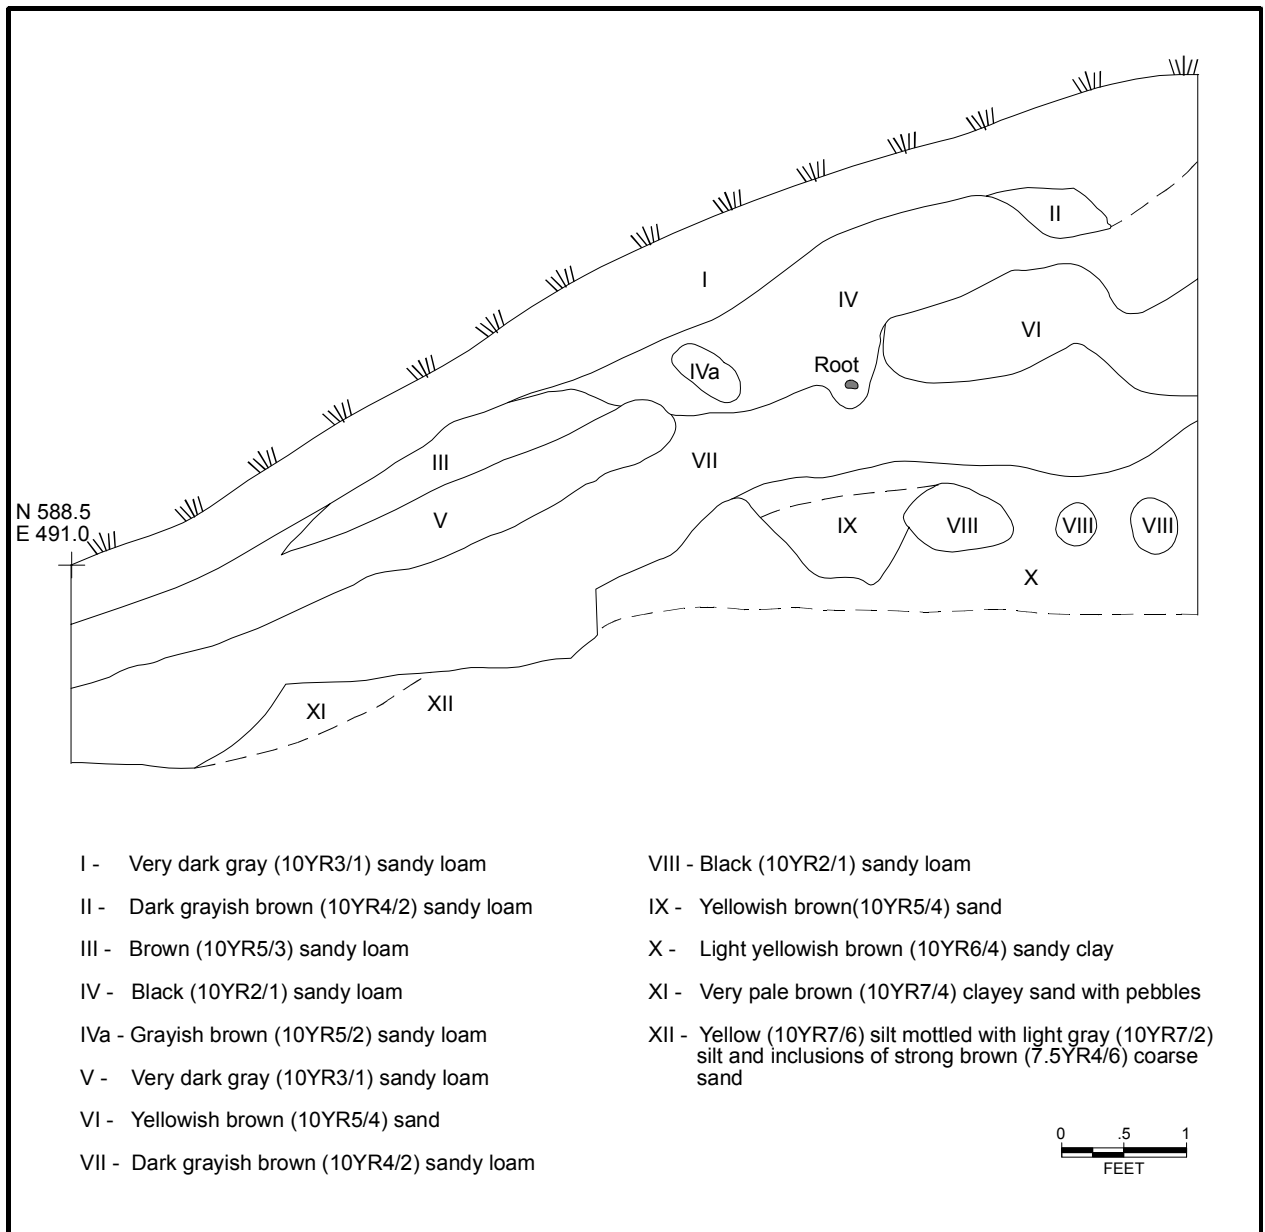
Figure 3.22. North profile of Trench 1.

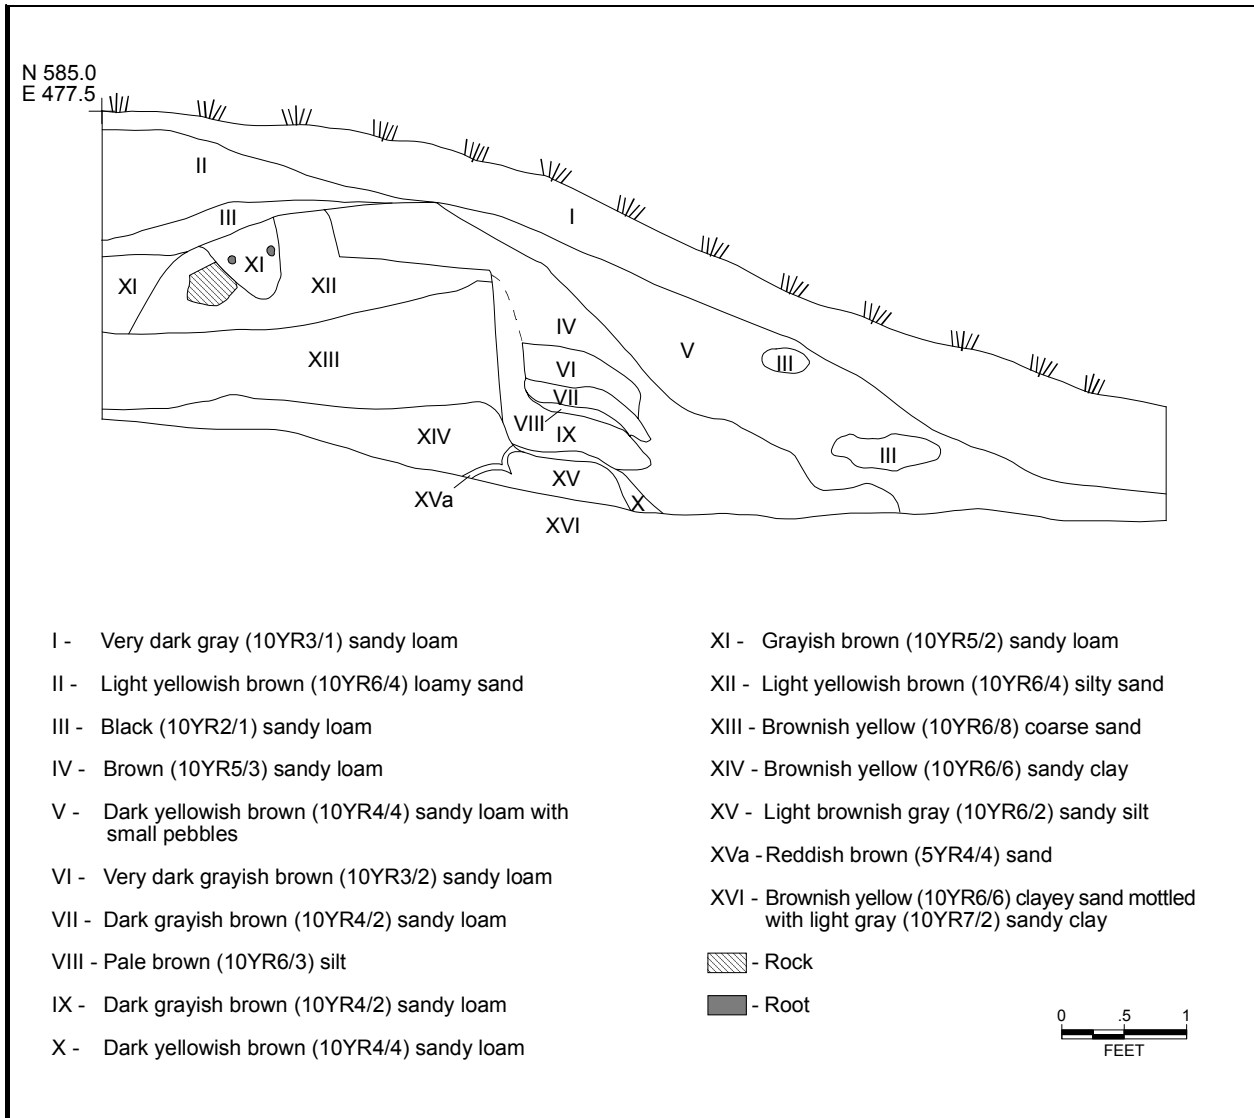
Figure 3.23. North profile of Trench 2.

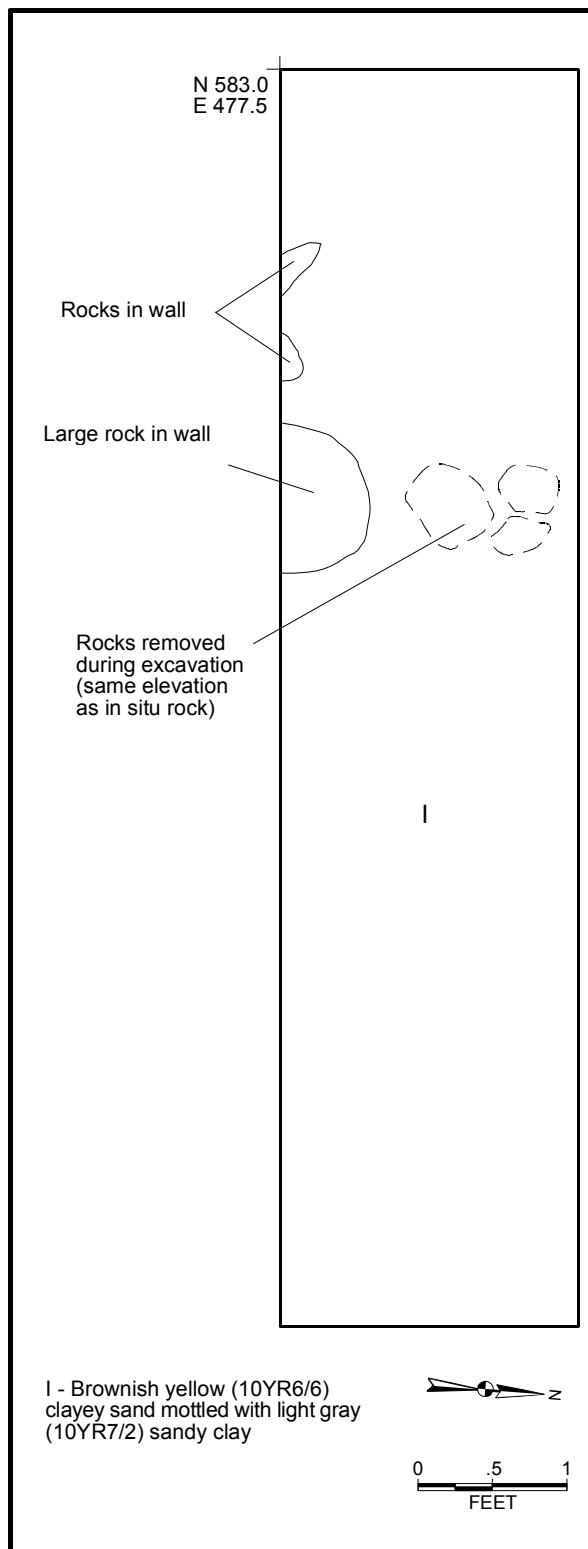
Figure 3.25. Plan of Trench 2.

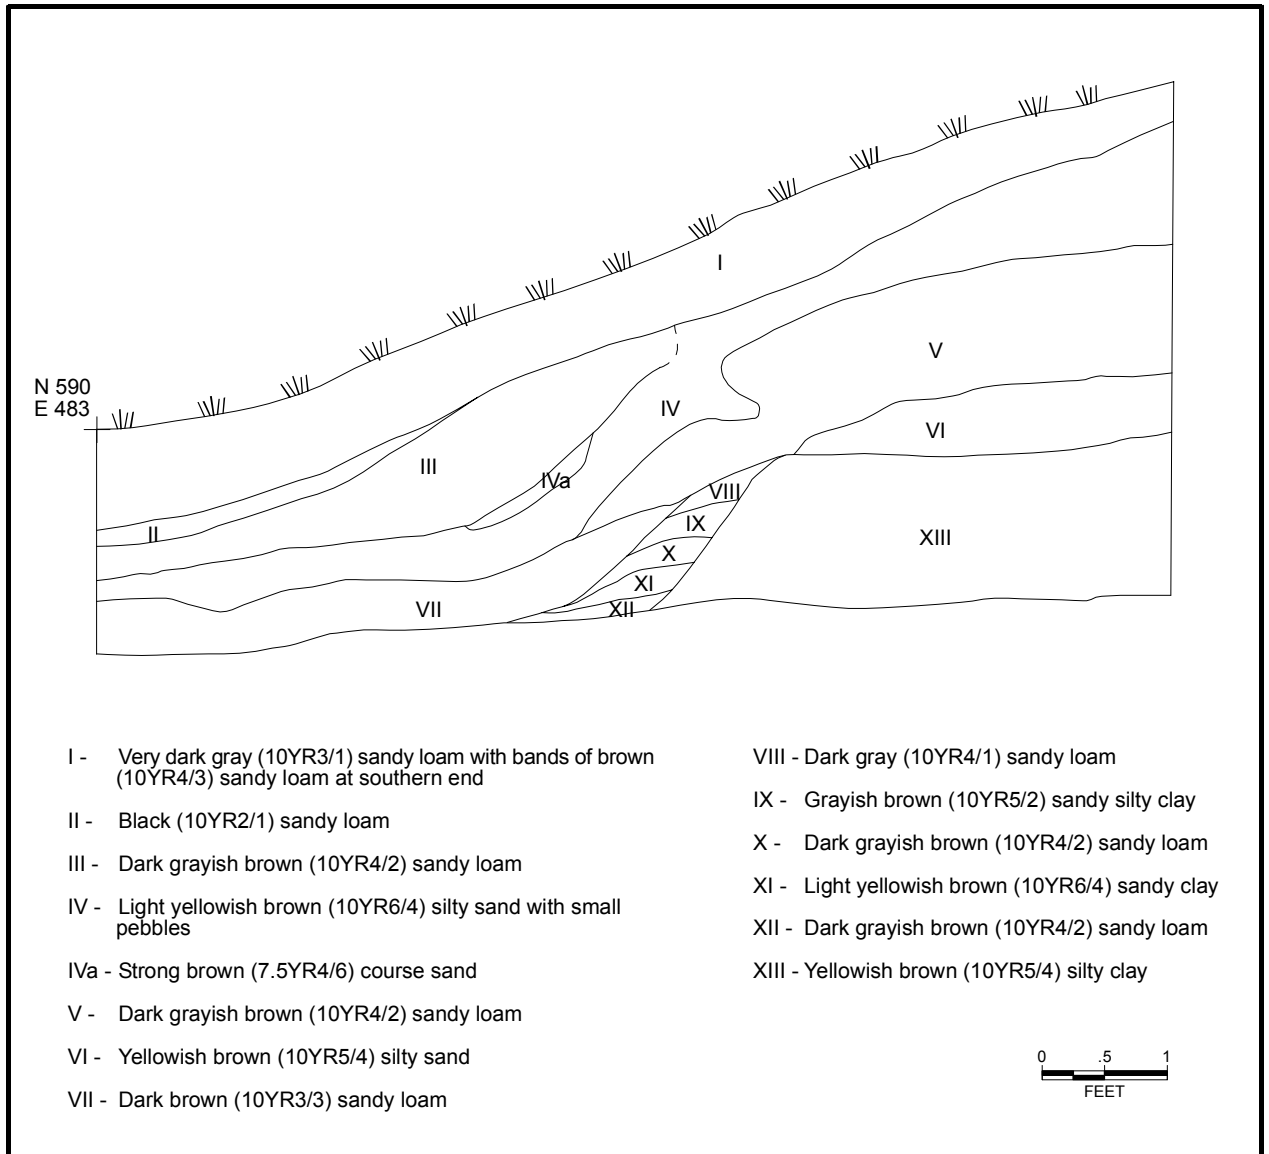
Figure 3.26. West profile of Trench 3.

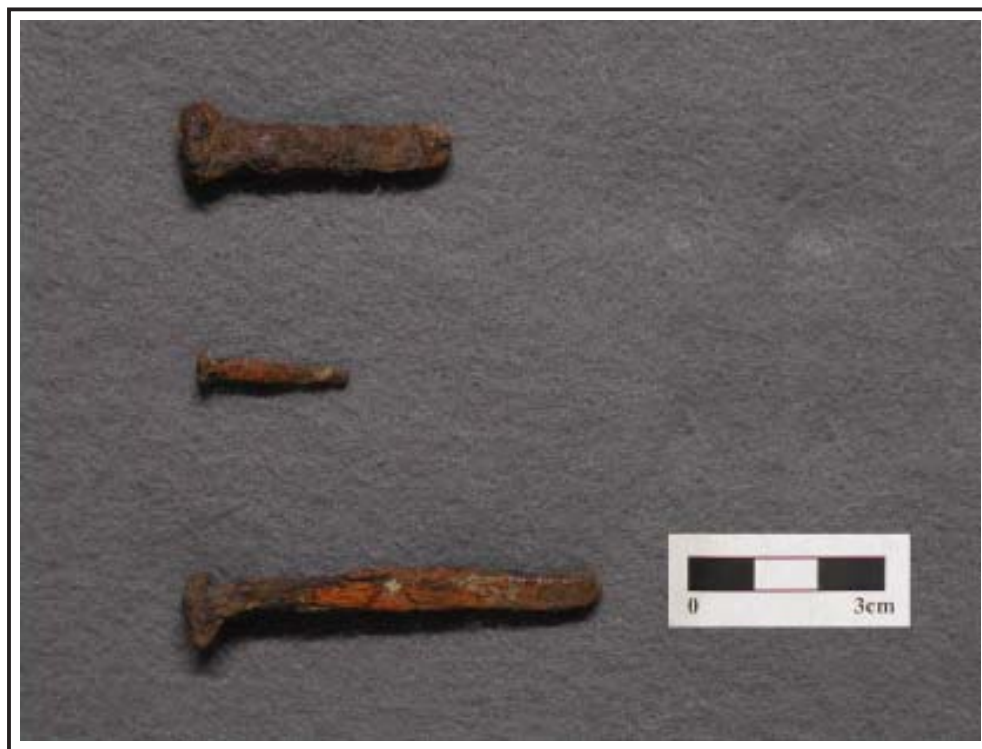
Figure 3.27. Cut nails recovered from the dugout excavation.
