**DIGGING INTO A DUGOUT HOUSE (SITE 21SW17):
THE ARCHAEOLOGY OF NORWEGIAN IMMIGRANT
ANNA BYBERG CHRISTOPHERSON GOULSON,
SWENODA TOWNSHIP, SWIFT COUNTY, MINNESOTA**

Technical Report No. 480

May 2003

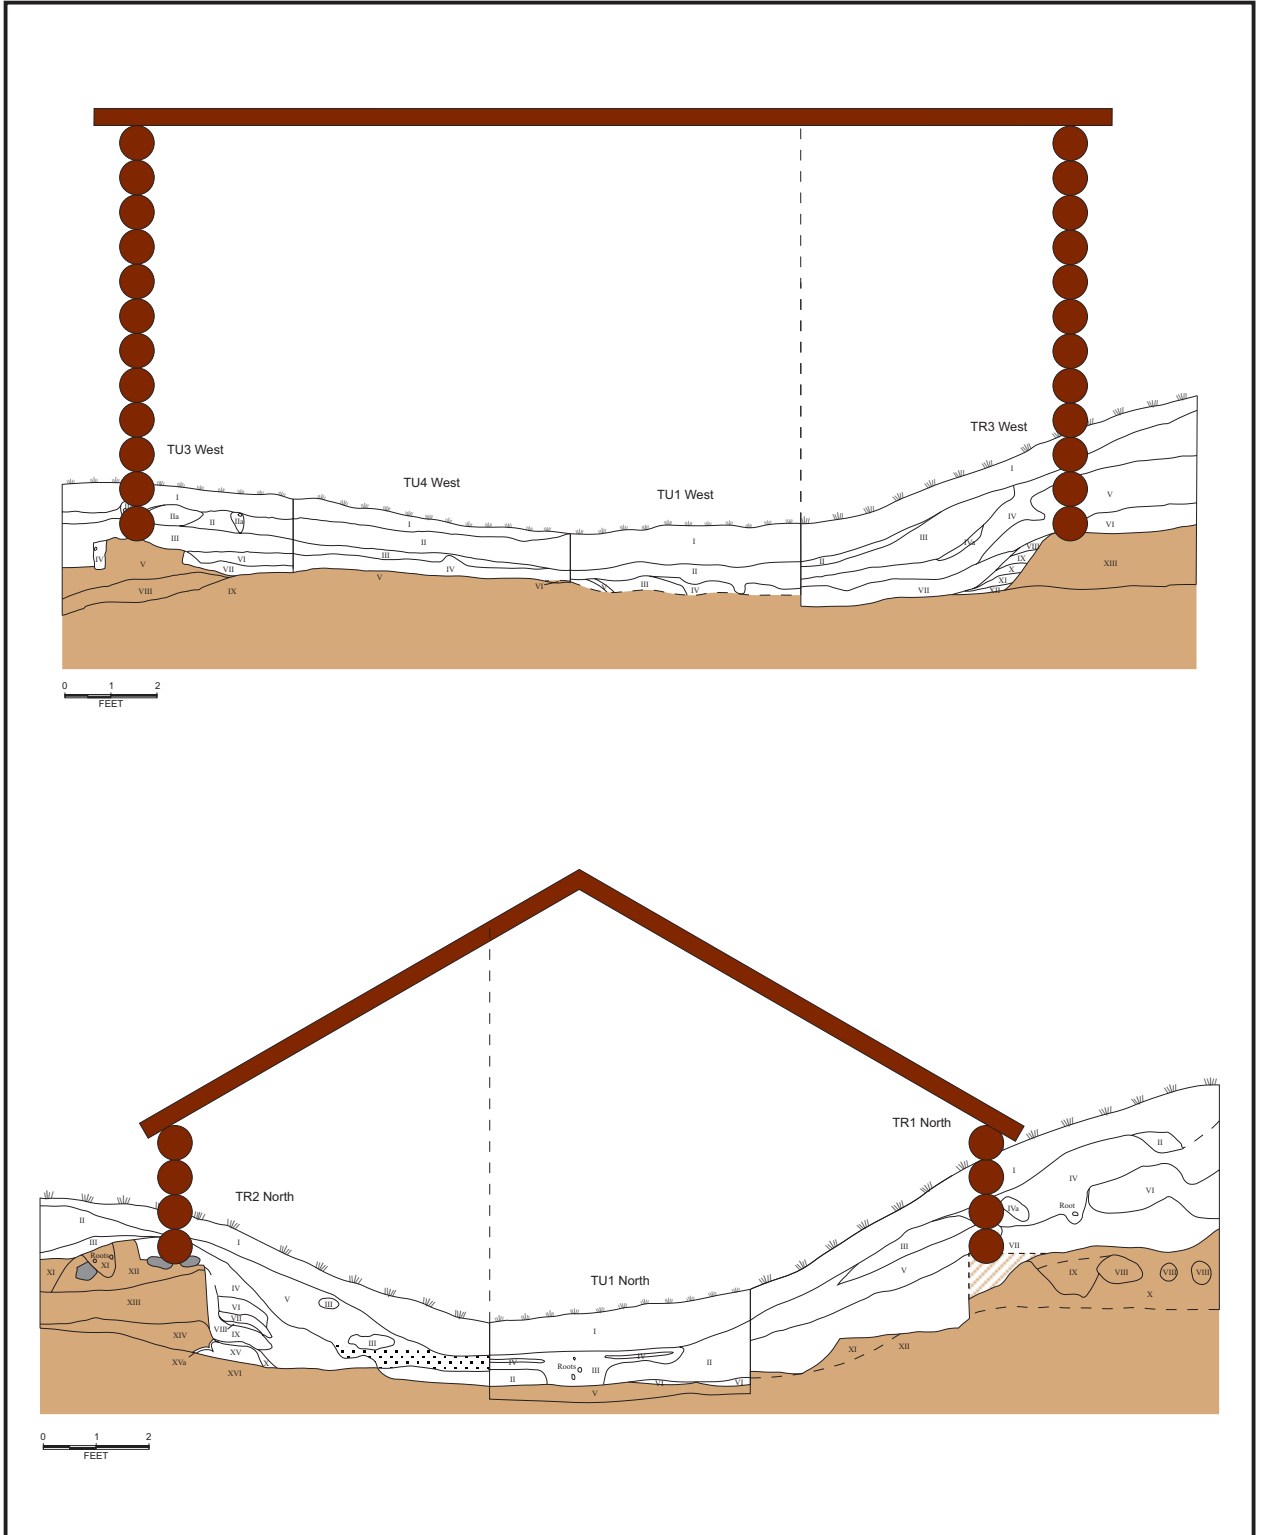
Figure 3.34. Conjectural reconstruction of Christopherson/Goulson dugout using log upper walls and gable roof.

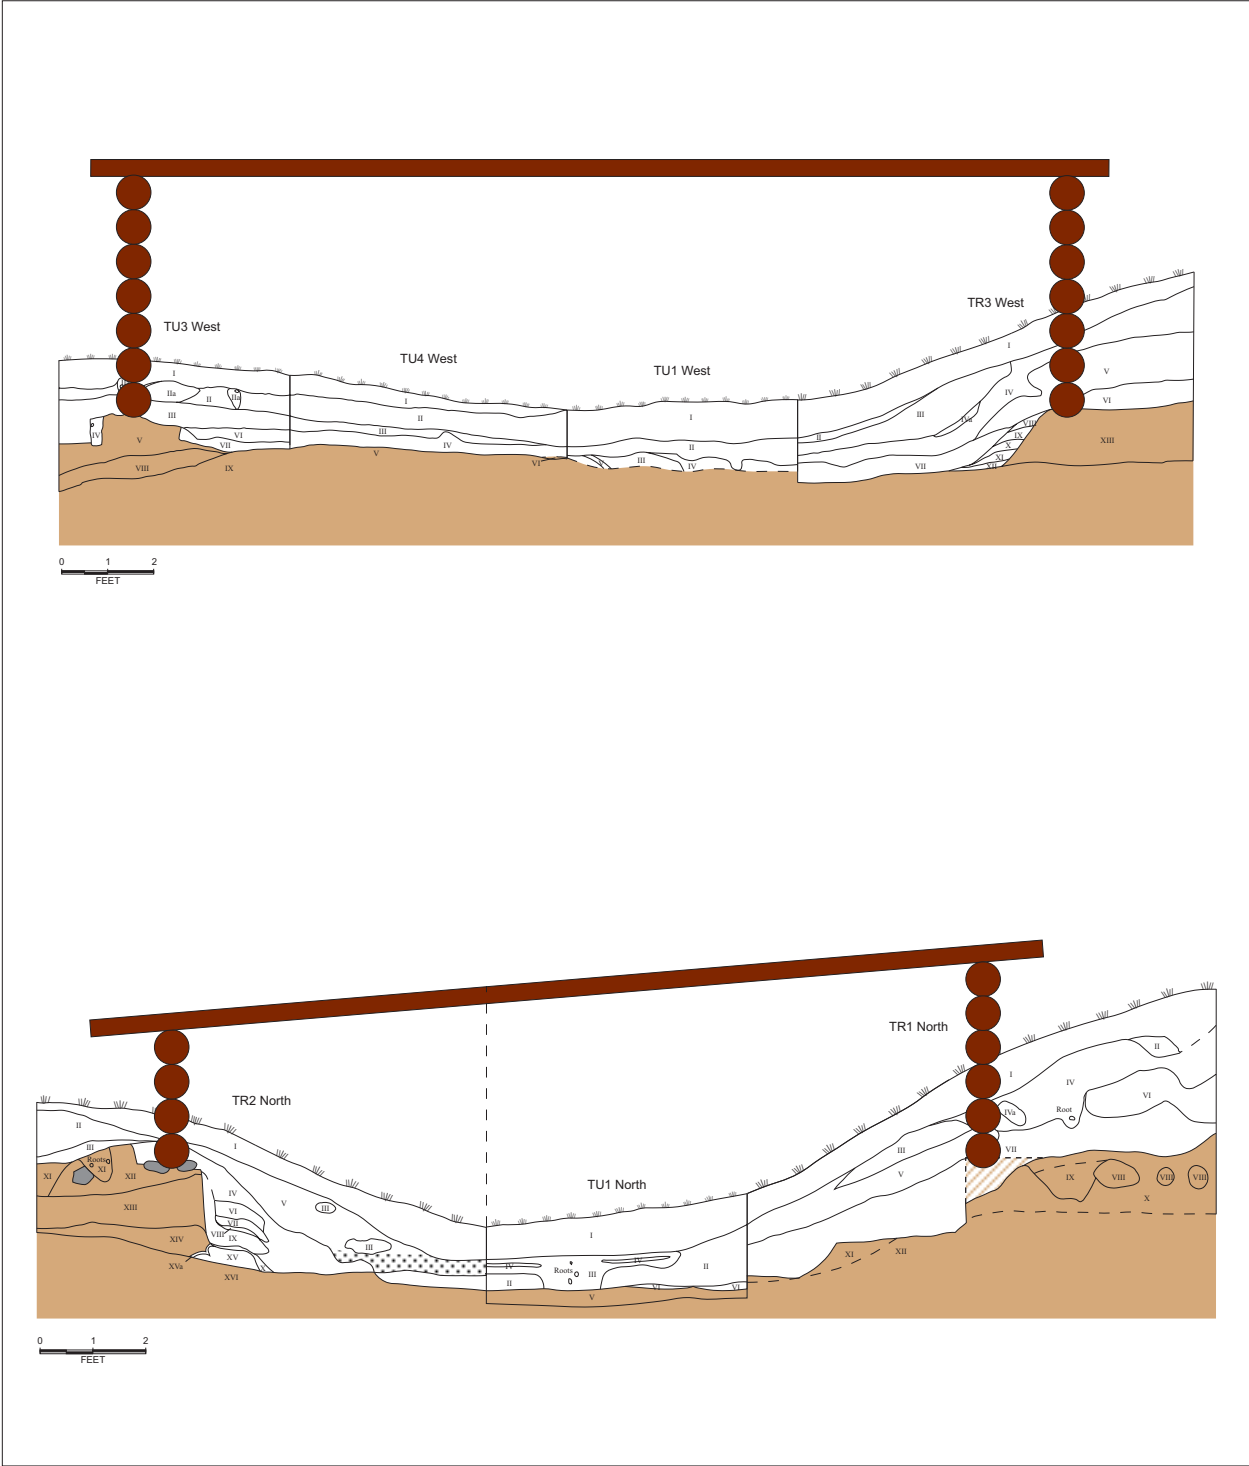
Figure 3.35. Conjectural reconstruction of Christopherson/Goulson dugout using log upper walls and shed roof.

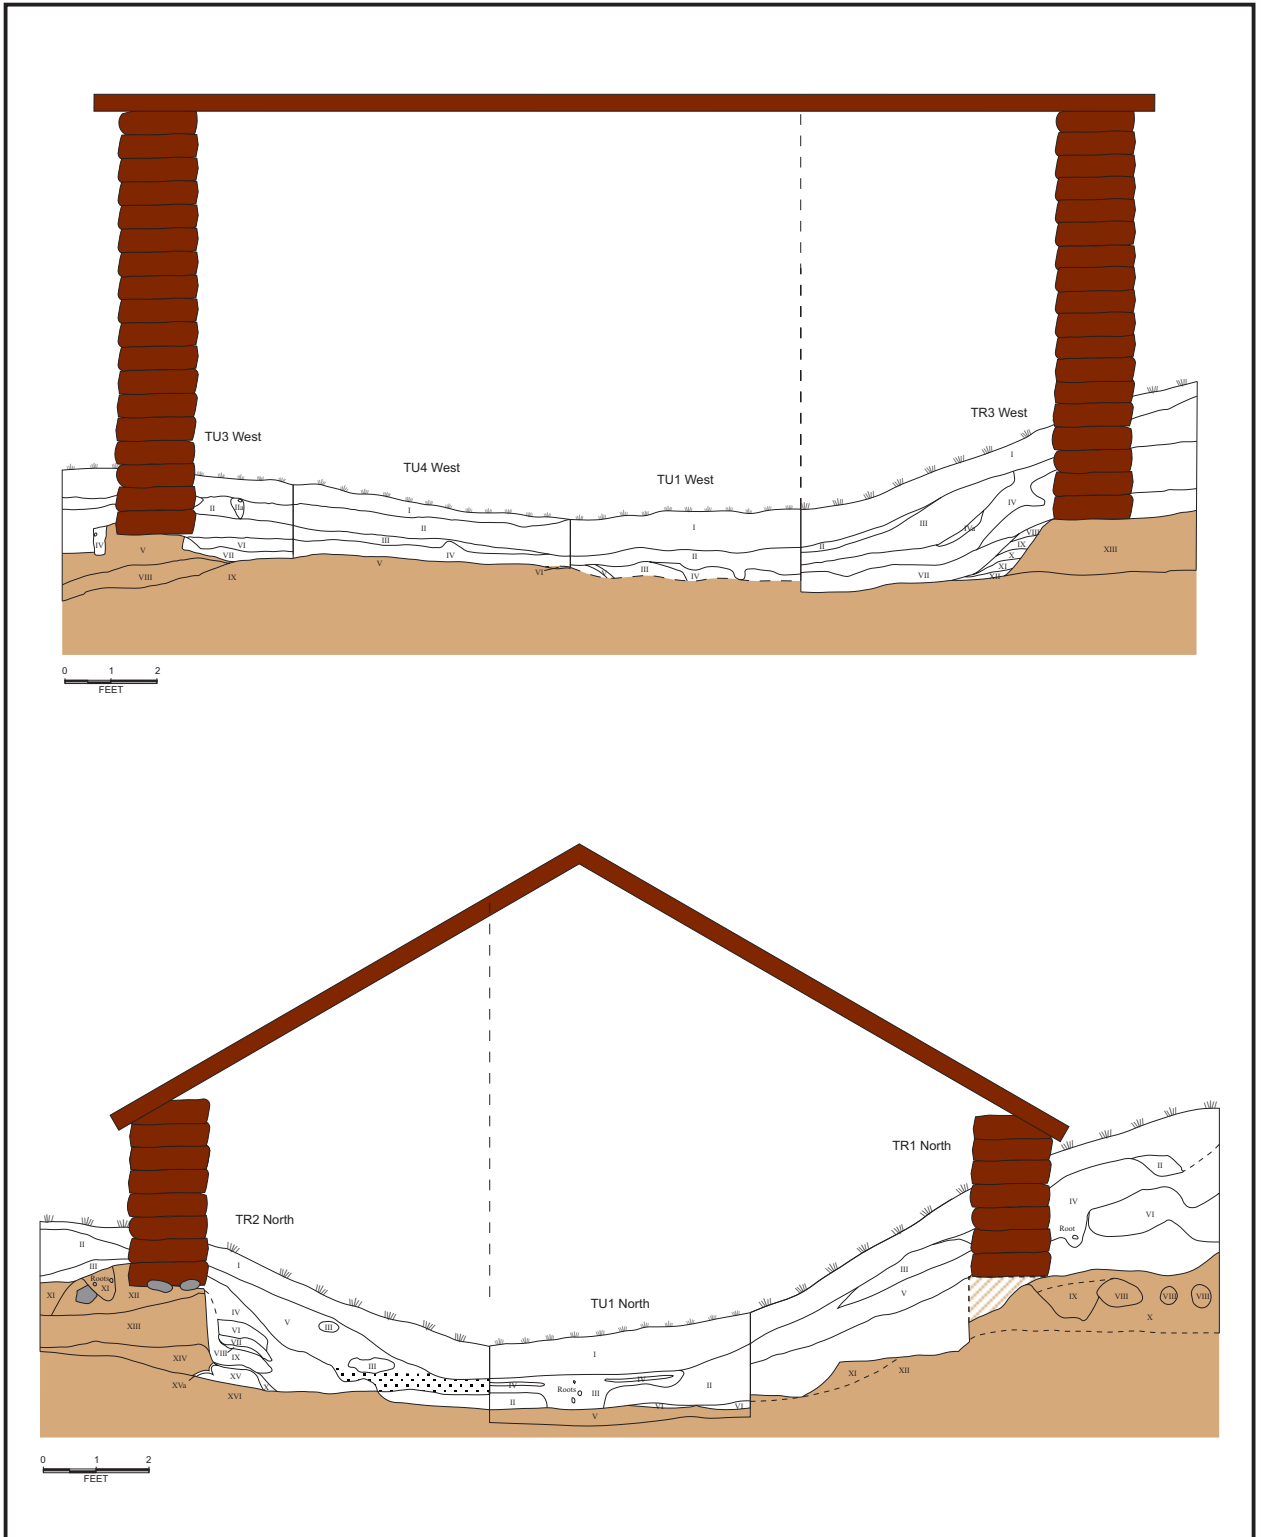
Figure 3.36. Conjectural reconstruction of Christopherson/Goulson dugout using sod block upper walls and gable roof.

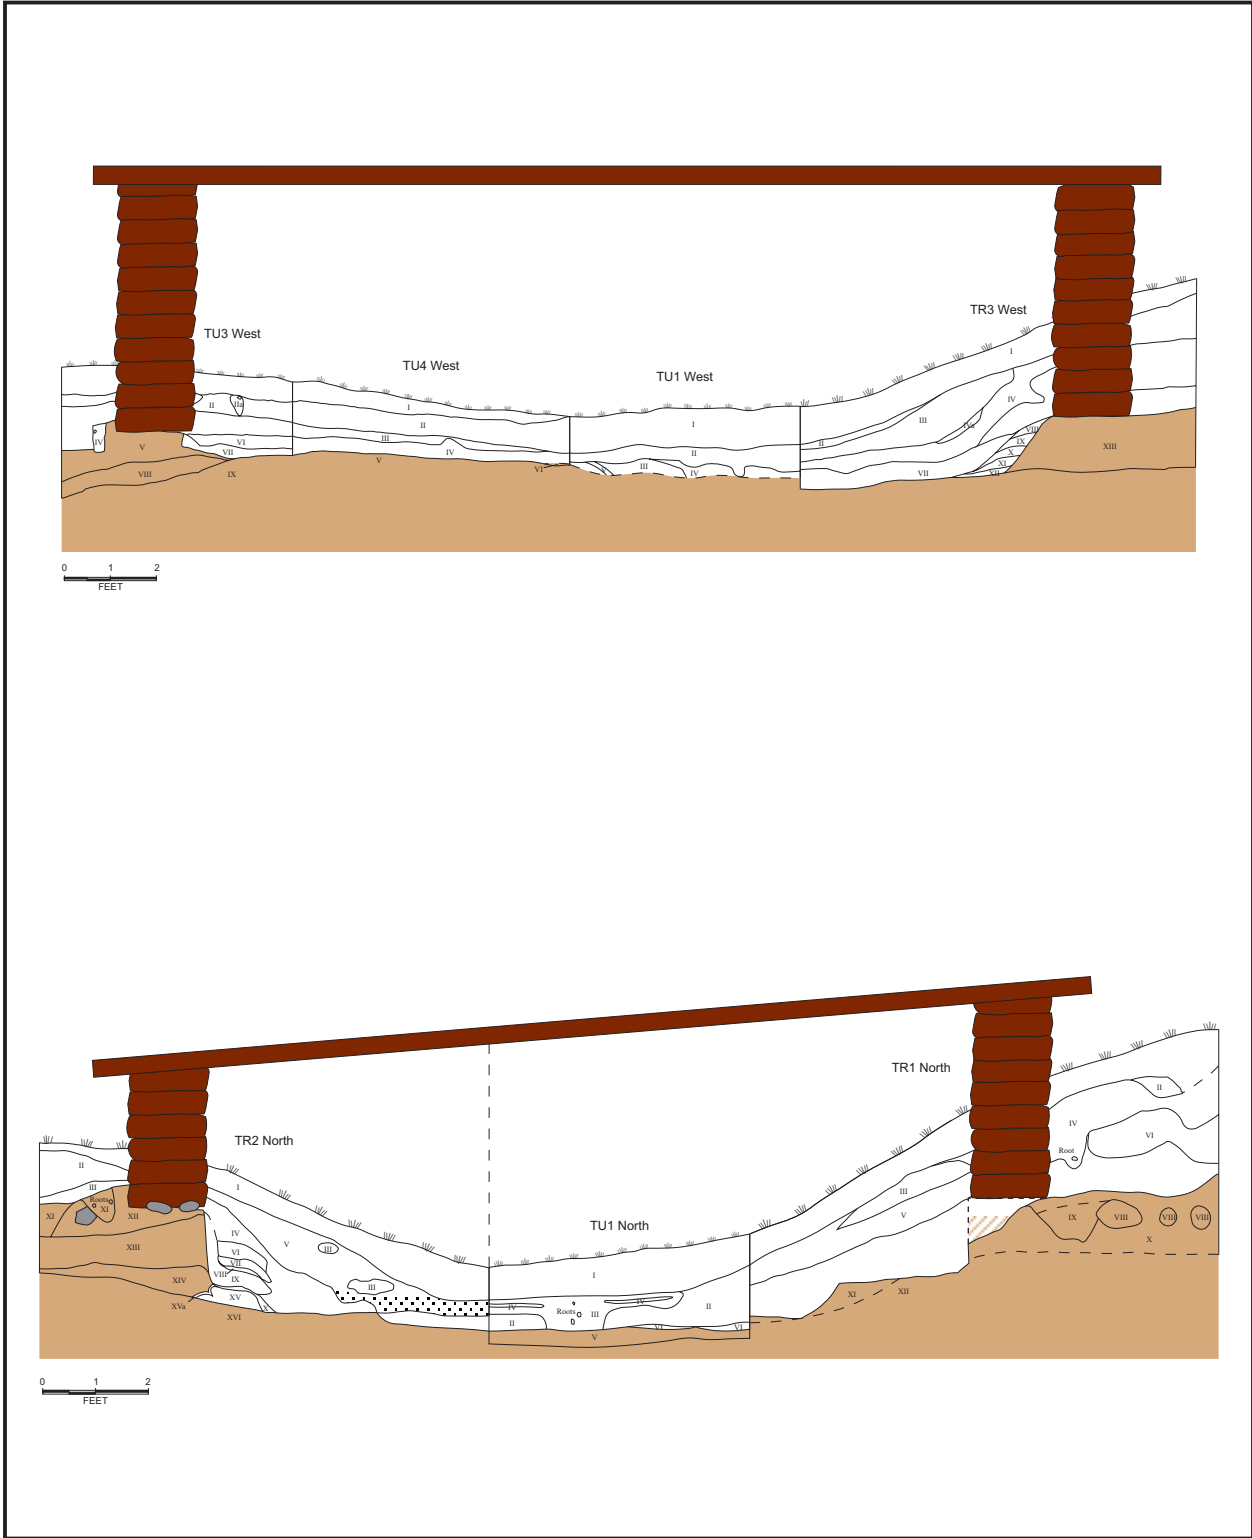
Figure 3.37. Conjectural reconstruction of Christopherson/Goulson dugout using sod block upper walls and shed roof.

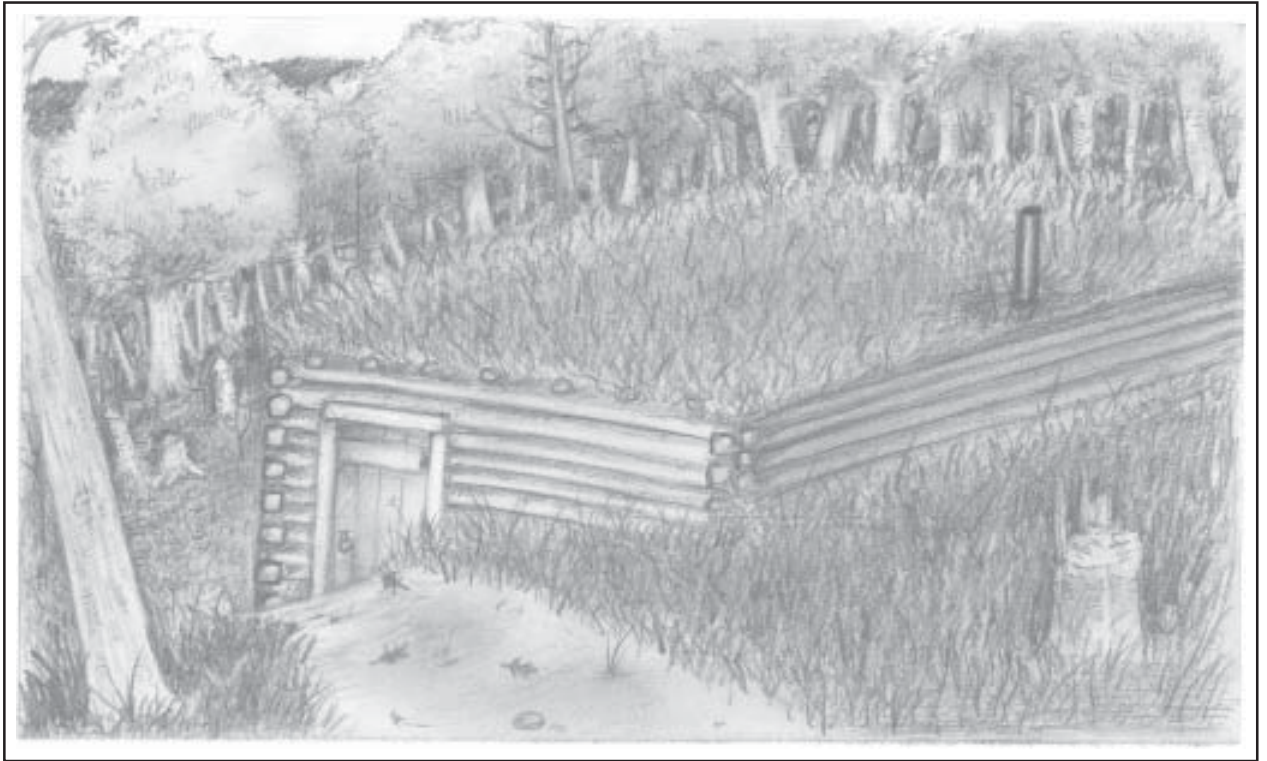
Figure 3.38. Conjectural drawing of Christopherson/Goulson dugout (Steve Culler).

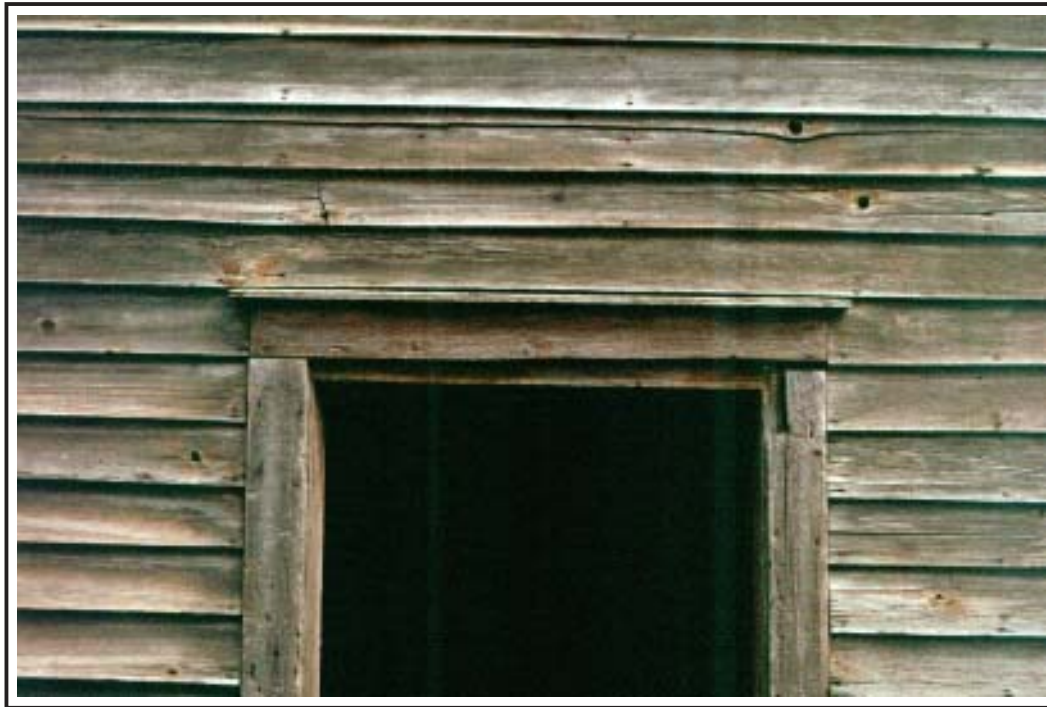
Figure 4.4. Detail of the front door trim, Goulson frame house, ca. 1880.

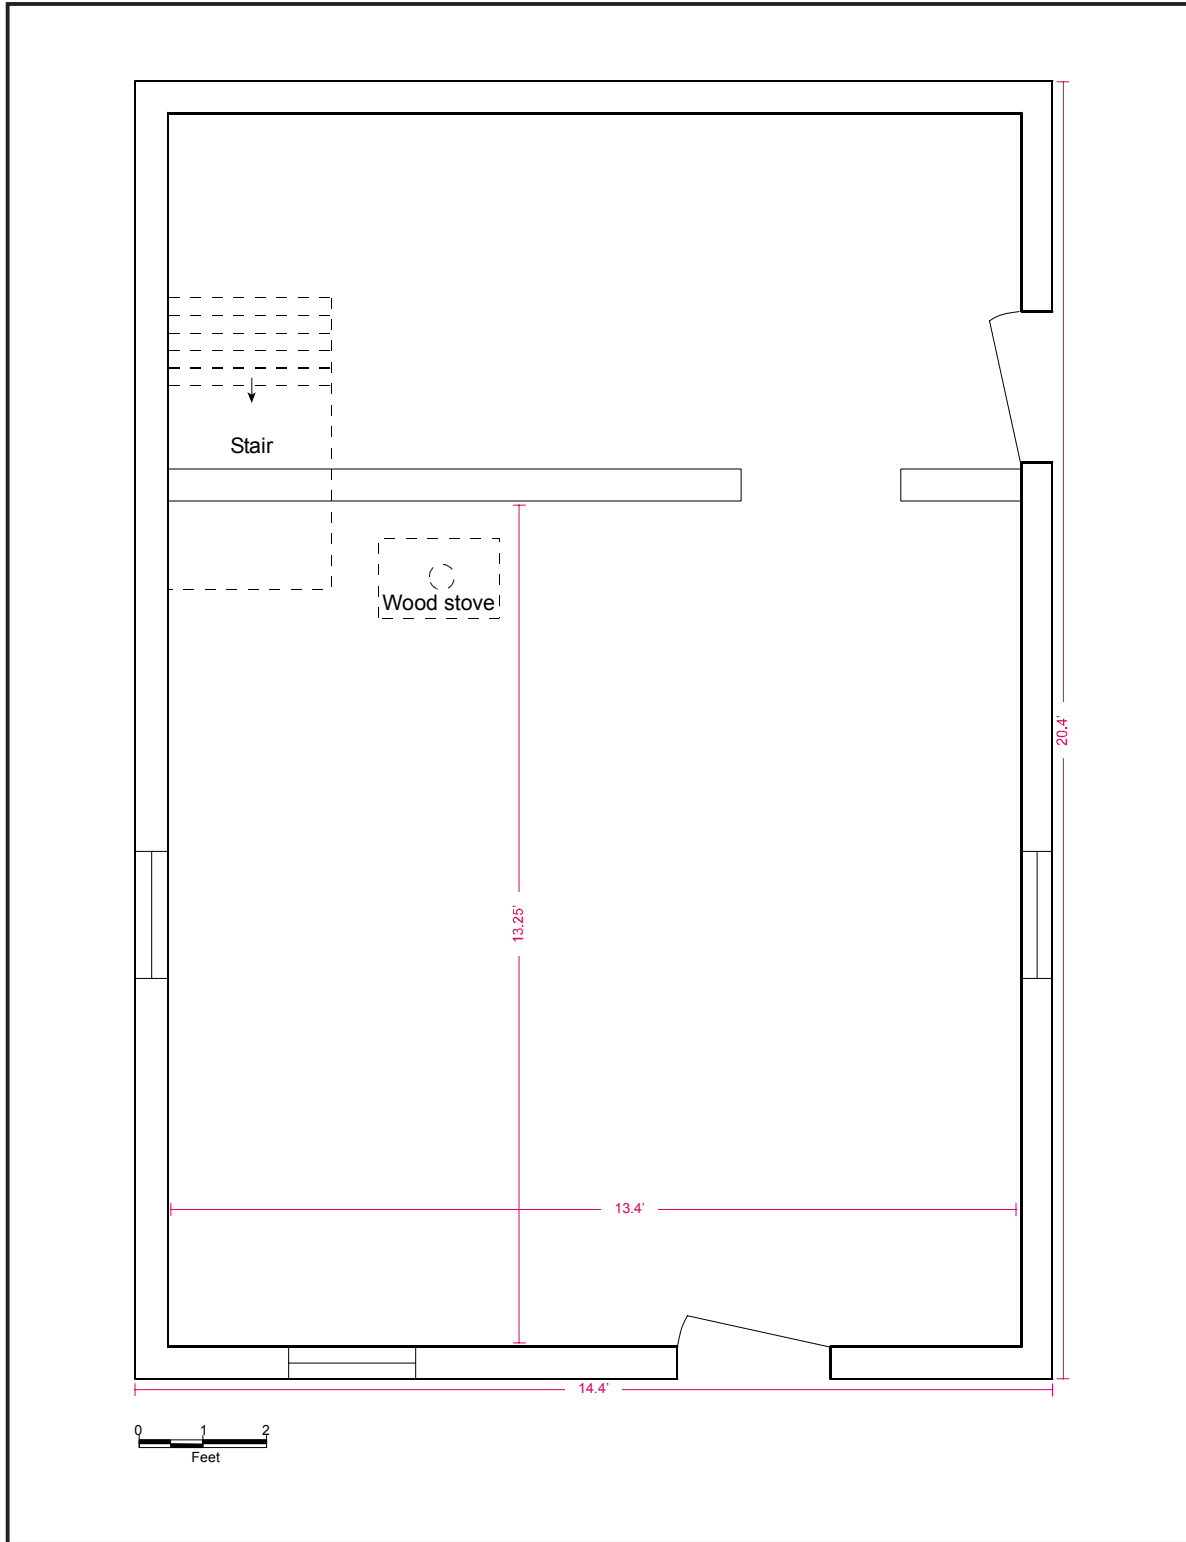
Figure 4.8. First floor plan of Goulson frame house, ca. 1880.

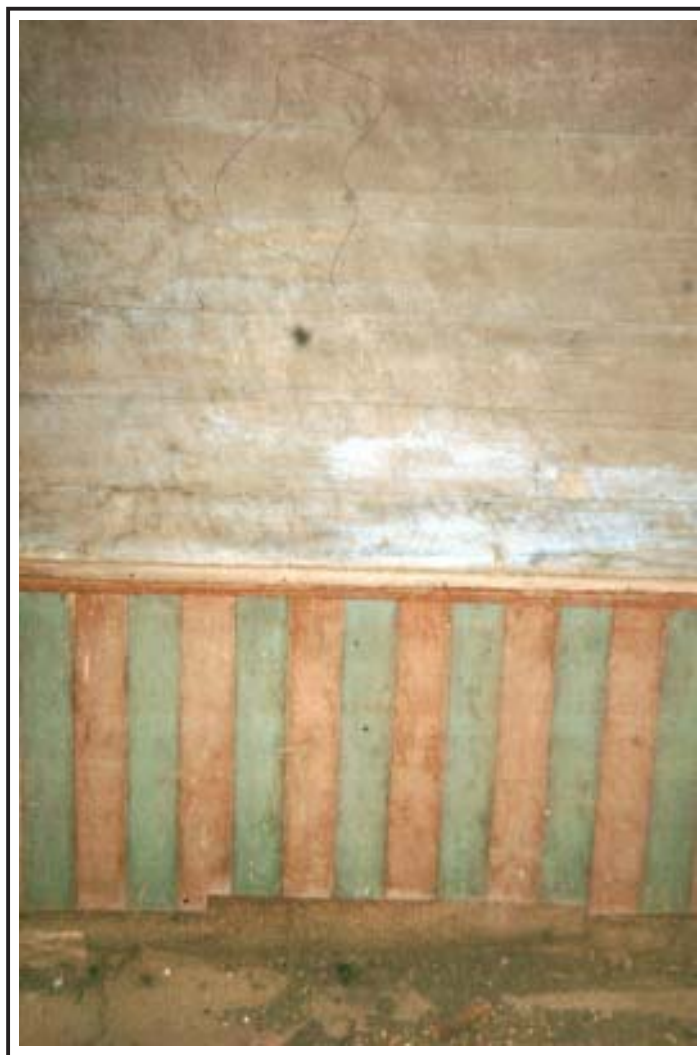
Figure 4.9. Wainscoting and chair rail in front room, Goulson frame house, ca. 1880.

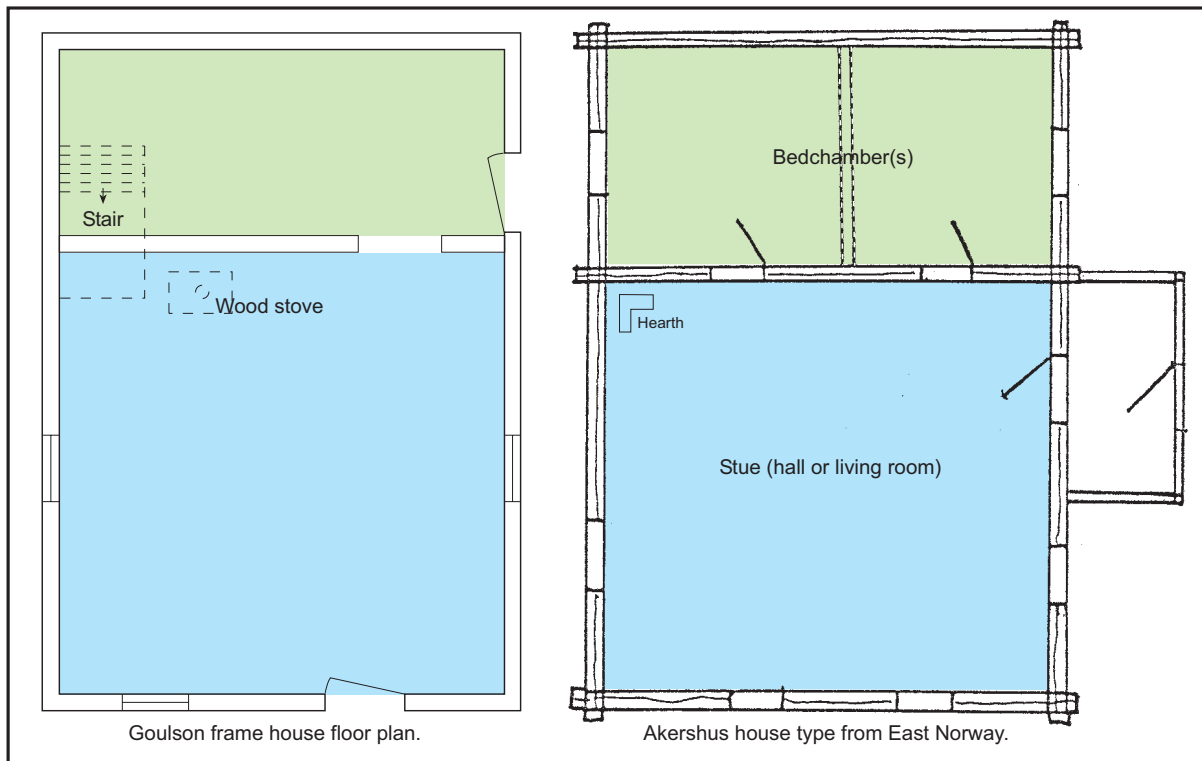
Figure 4.11. Goulson frame house floor plan, ca. 1880 and Akershus house floor plan (after Bakken 1994:77, 80).
